TANK 2 ENGINEERING REVIEW AND SUITABILITY FOR SERVICE EVALUATION

API 653 OUT-OF-SERVICE TANK INSPECTION BY OTHERS

**FISC PEARL HARBOR
RED HILL COMPLEX, HAWAII**

Final Report October 2008

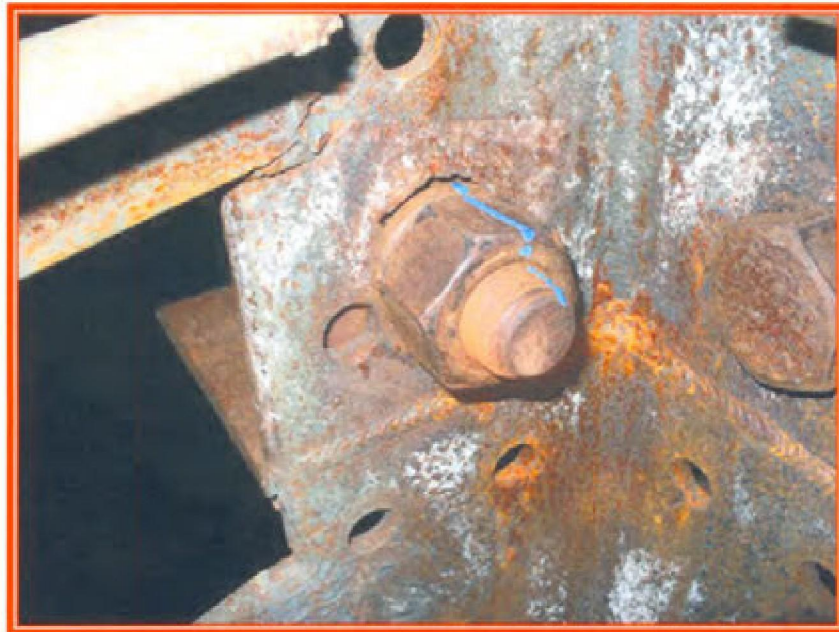
Photo #1: *Visible slippage of the bolt connection*

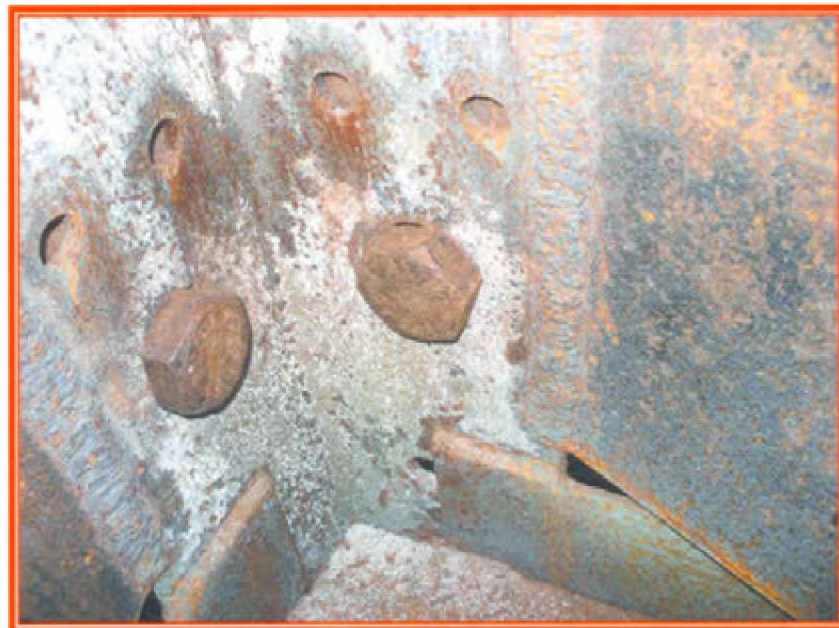
Photo #2: *Visible slippage of the bolt connection*

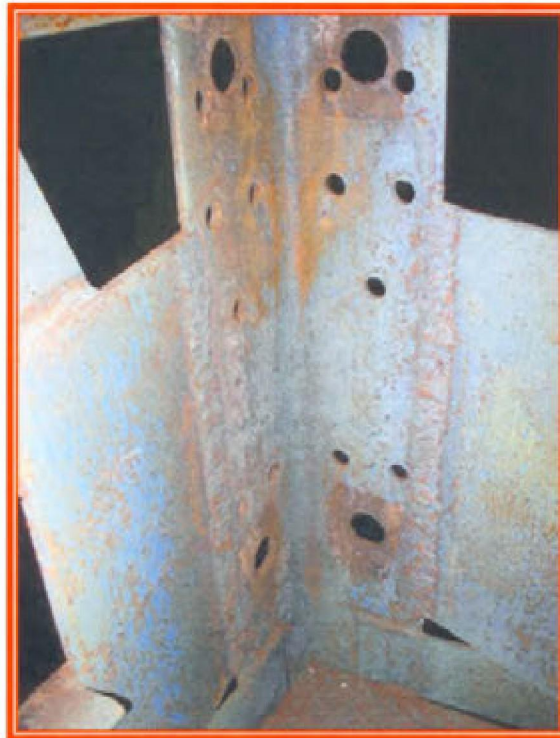
Photo #3: *Big holes on the framing members*

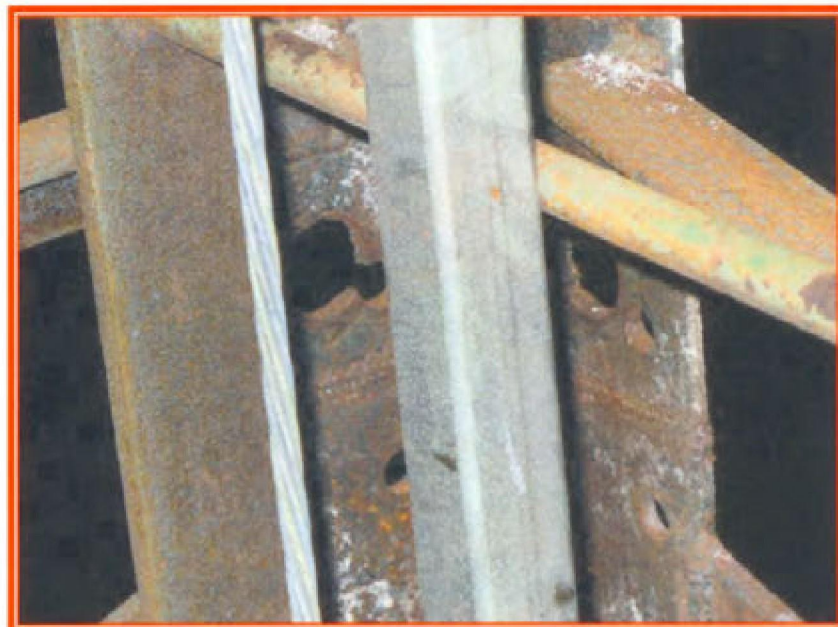
Photo #4: *Big holes on the framing members*

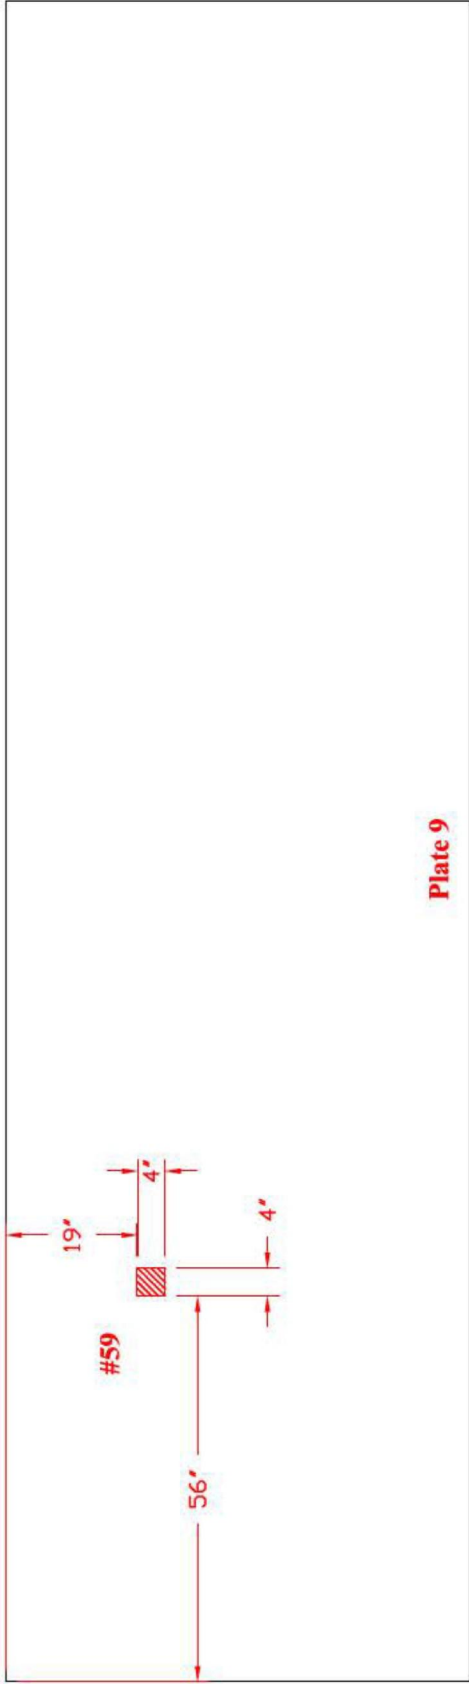
Course: 22
Plate #: 9

Flaw # - Type - Remaining:
#59 - W.L. - .186"

Flaw # 59: The waveform above depicts underside corrosion exhibiting 0.186" wall remaining.

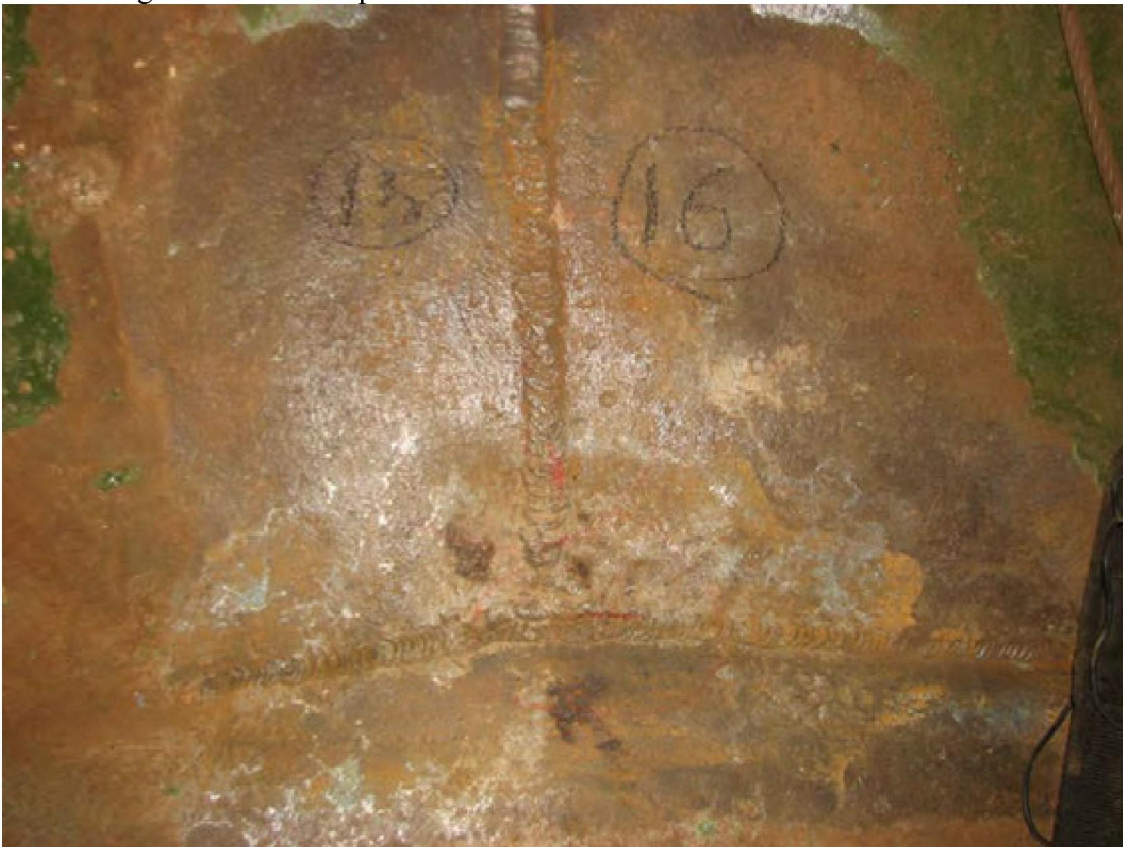
Intersecting welds between plates 15 and 16 of course 1 and the floor.

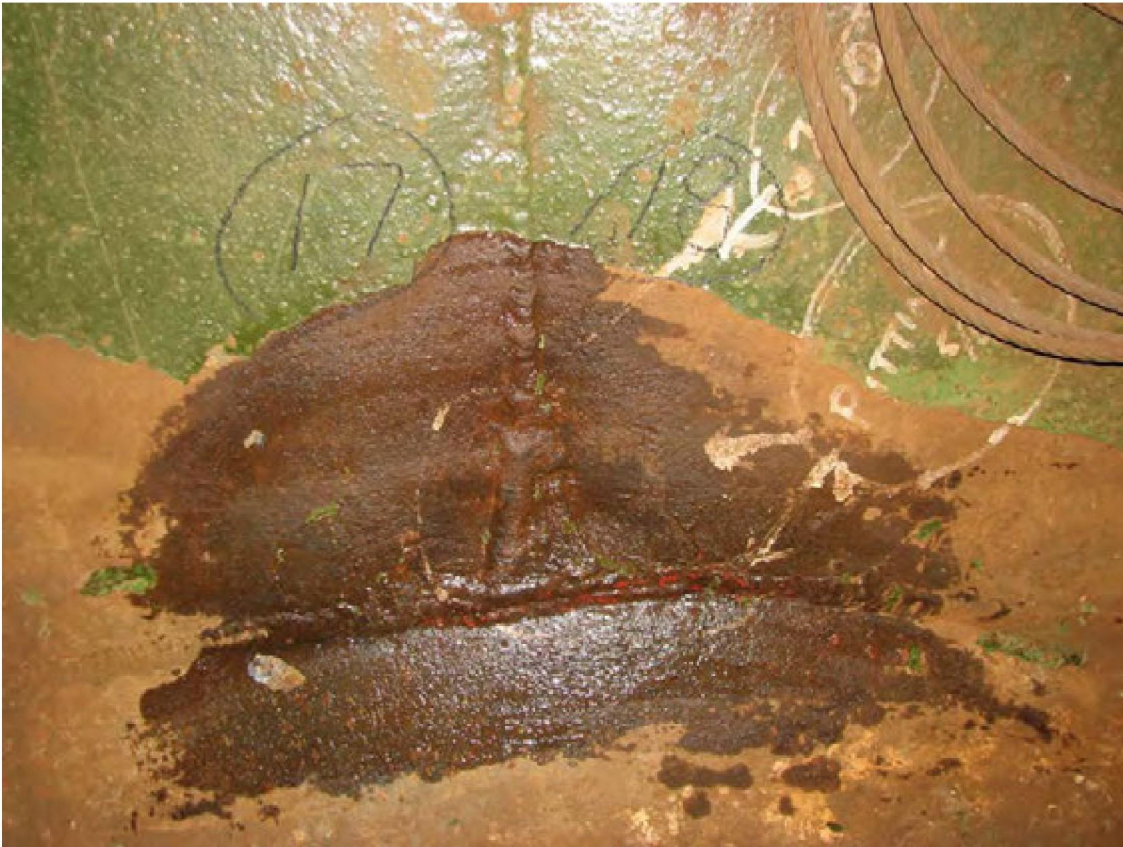
Intersecting welds between plates 17 and 18 of course 1 and the floor.

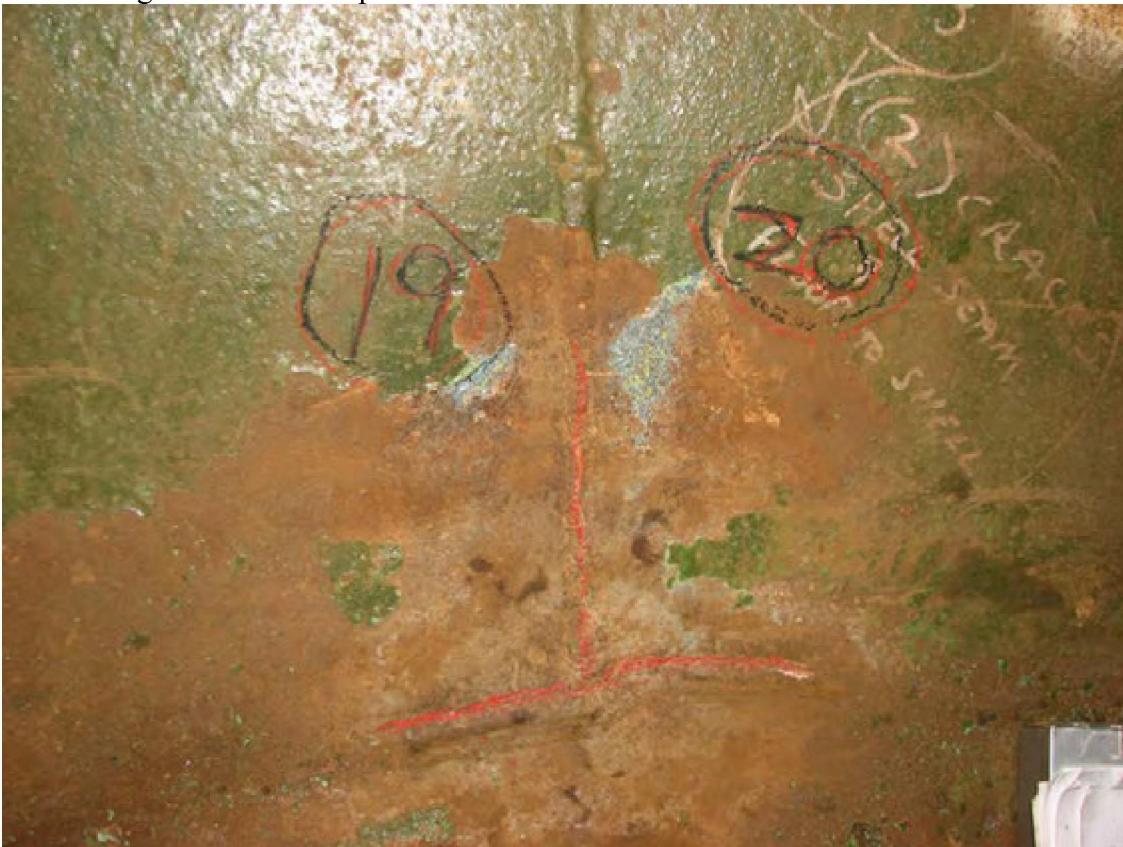
Intersecting welds between plates 19 and 20 of course 1 and the floor.

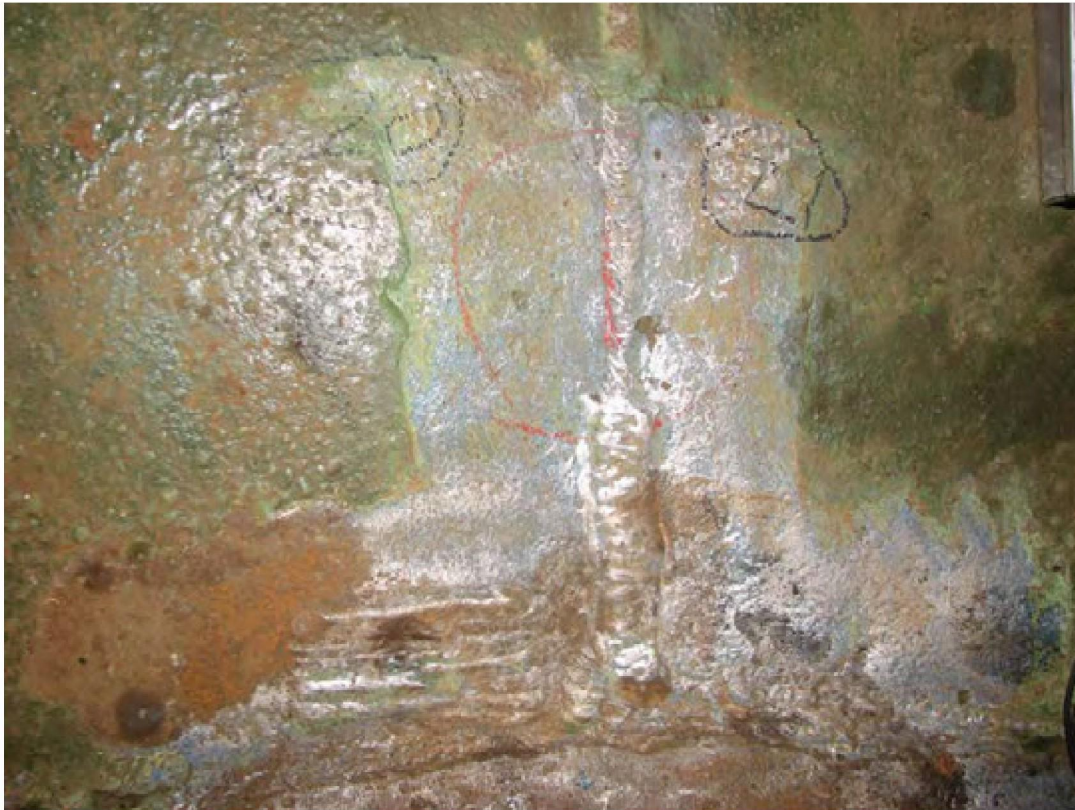
Intersecting welds between plates 20 and 21 of course 1 and the floor.

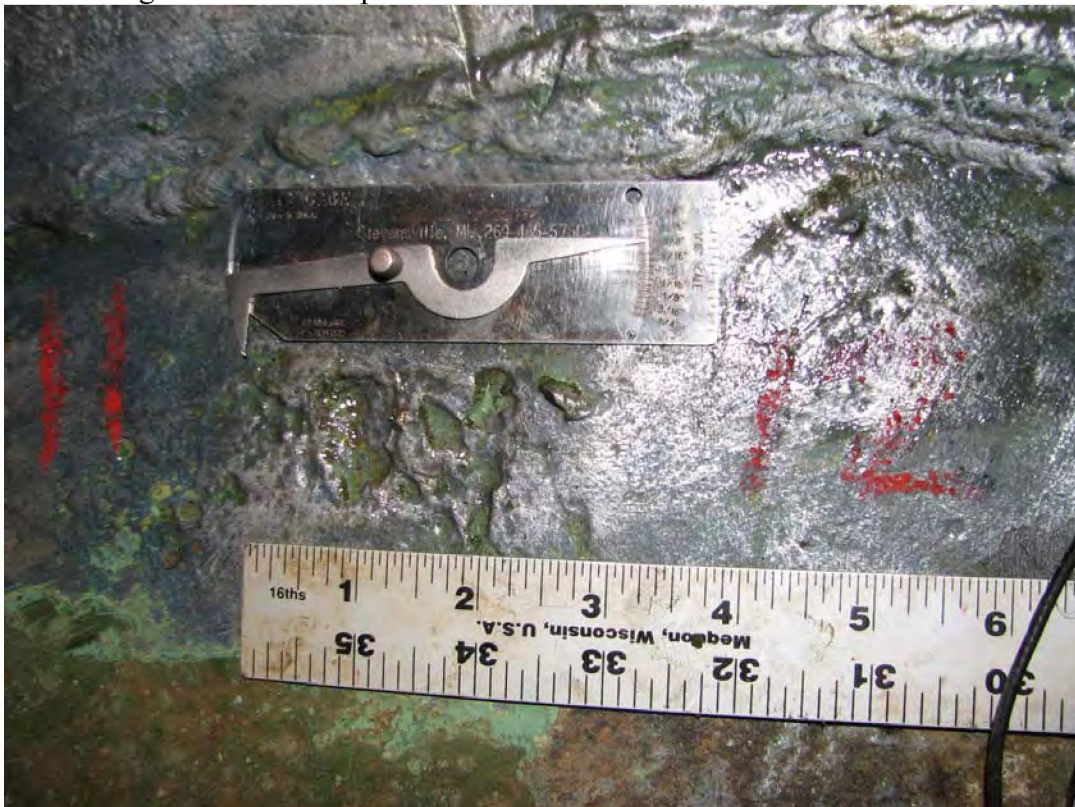
Flaw # 83, topside pitting on plate 4 of the floor, 0.336" remaining, near plates 11 and 12 of course 1
