**MODIFIED API-653 OUT-OF-SERVICE
TANK 20
RED HILL**

December 5, 2008

Subject: Tank No. 20 Red Hill Fuel Facility

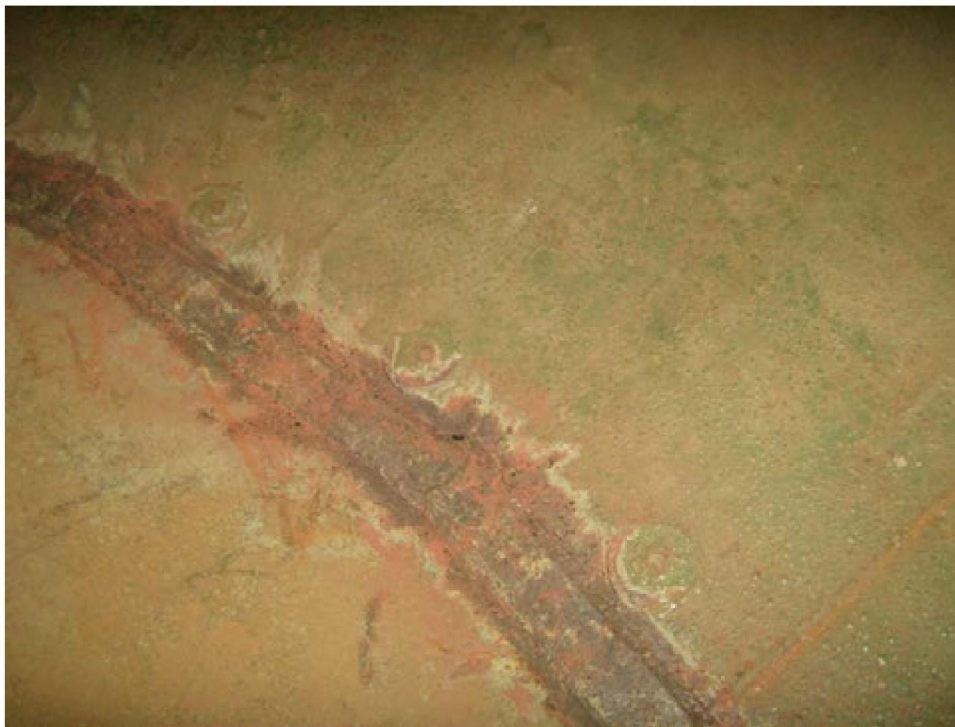
Transition from tank floor to the lower dome section

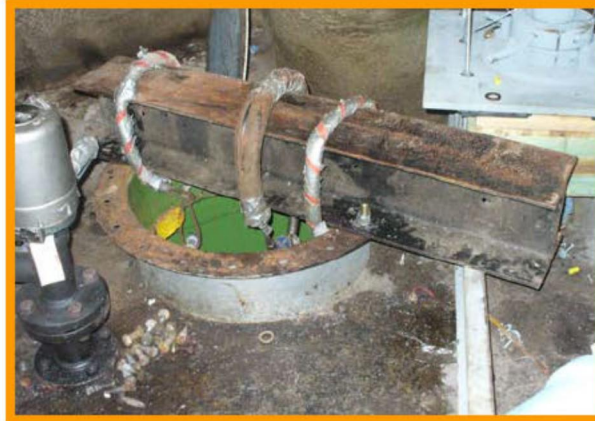
The assembly consists of three cables anchored on the top by a 42" long 8x8 I-Beam resting on a 1/4" thick top flange plate of the dome(See Image #3).

Image #3: Showing Tank #20 Spider hoist assembly top anchoring

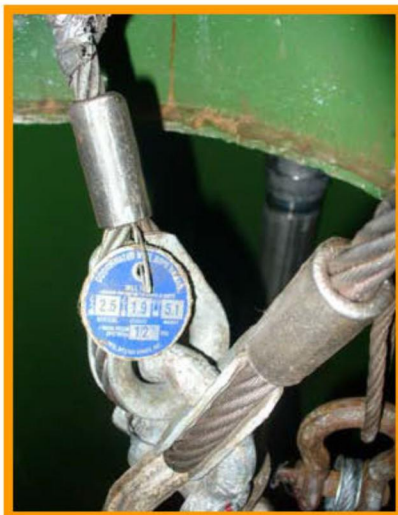
A 5/16" spider hoist cable is attached to the top anchor I-Beam with a 3/8" choke cable and 5/8" diameter shackle (attached to a 7/8" shackle). The life line cables are also 5/16" thick and attached to the top anchor I-Beam with a 5/16" choke cable and 5/8" shackles. (See Image #4)

Image #4: Showing Tank #20 Spider hoist assembly cables and shackles

The Working Load Limit of a 5/16" choke cable is 2000 pounds. The smallest shackle in the assembly holding the spider is 5/8" shackle with a Working Load Limit of 3-1/4 ton, or 6,500 pounds. The cable bends and shackles reduce the Safe load another 50%. Therefore, a safe

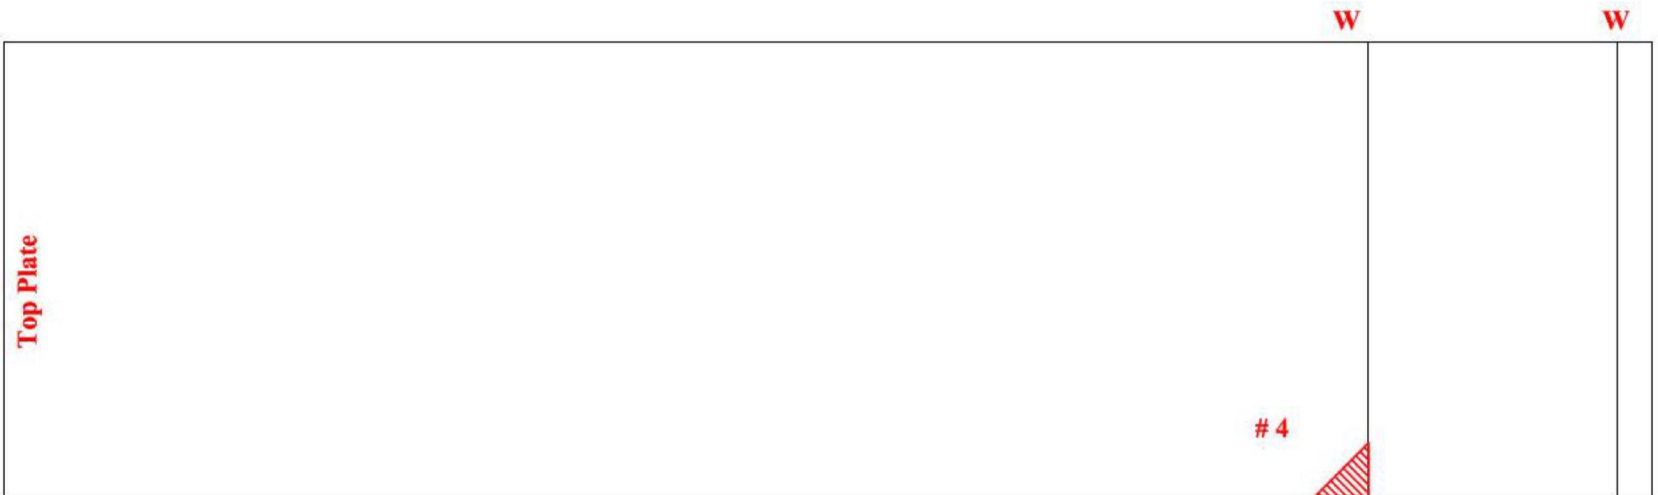
Flaw # - Type - Remaining:

#4 -Wall Loss (corner) - 0.240"R

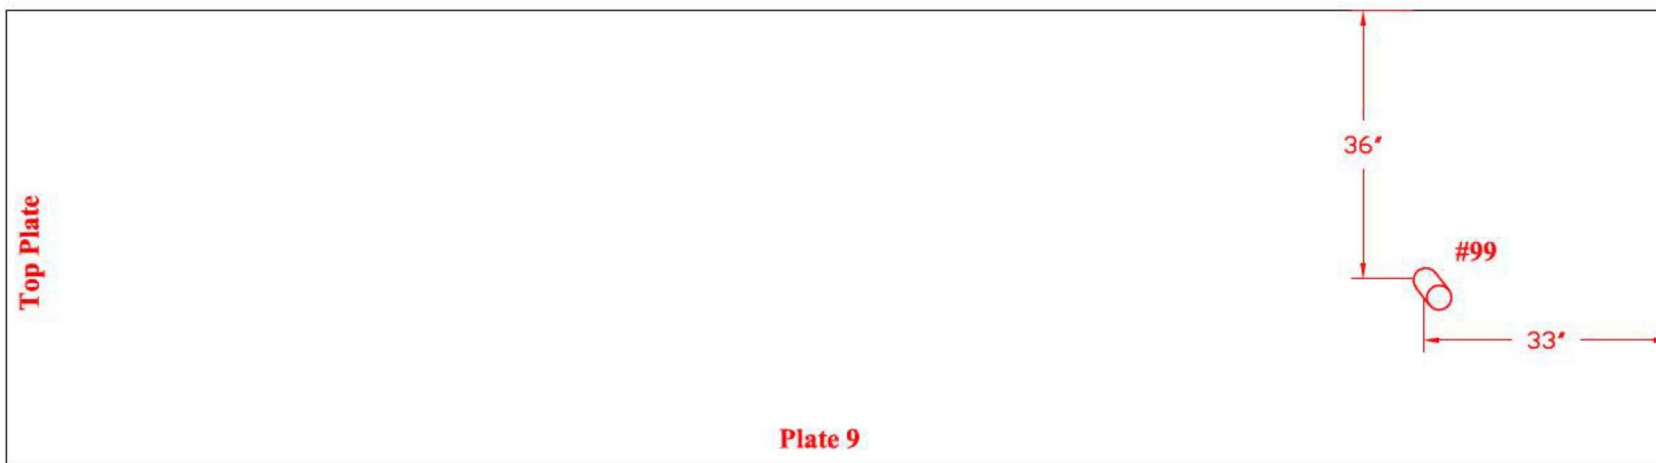
Course: 3
Plate #: 9

Flaw # - Type - Remaining:
#99 - Grout Nozzle - 0.198"R

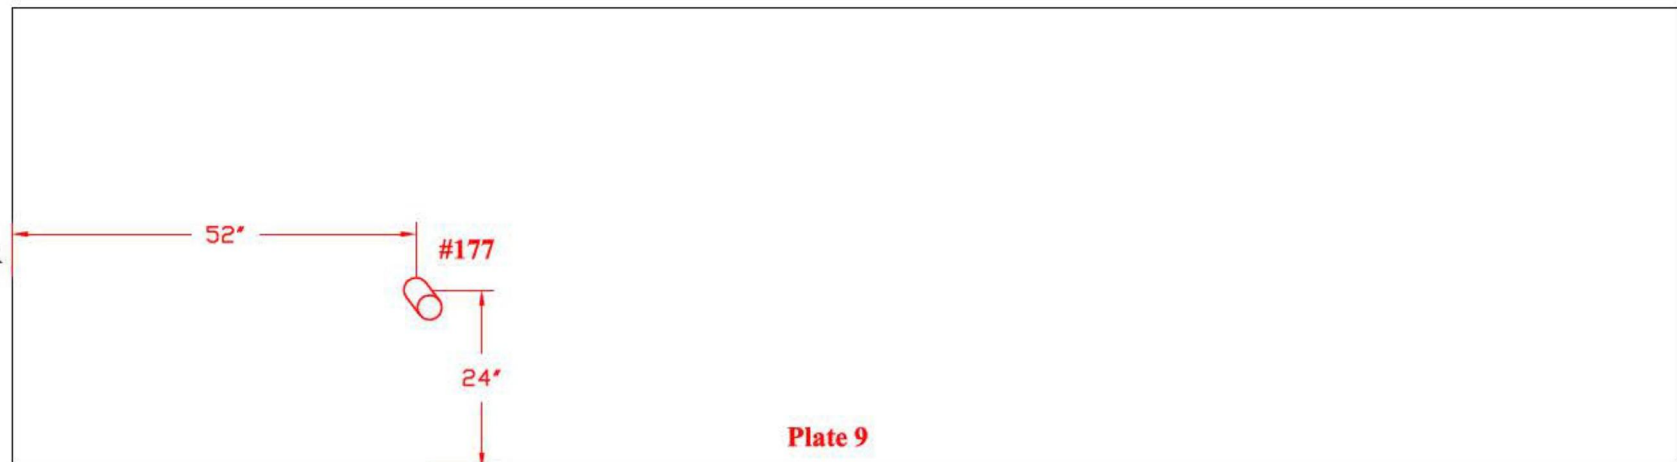
Course: 12
Plate #: 9
Flaw # - Type - Remaining:

#177 - Grout Nozzle - 0.204"R

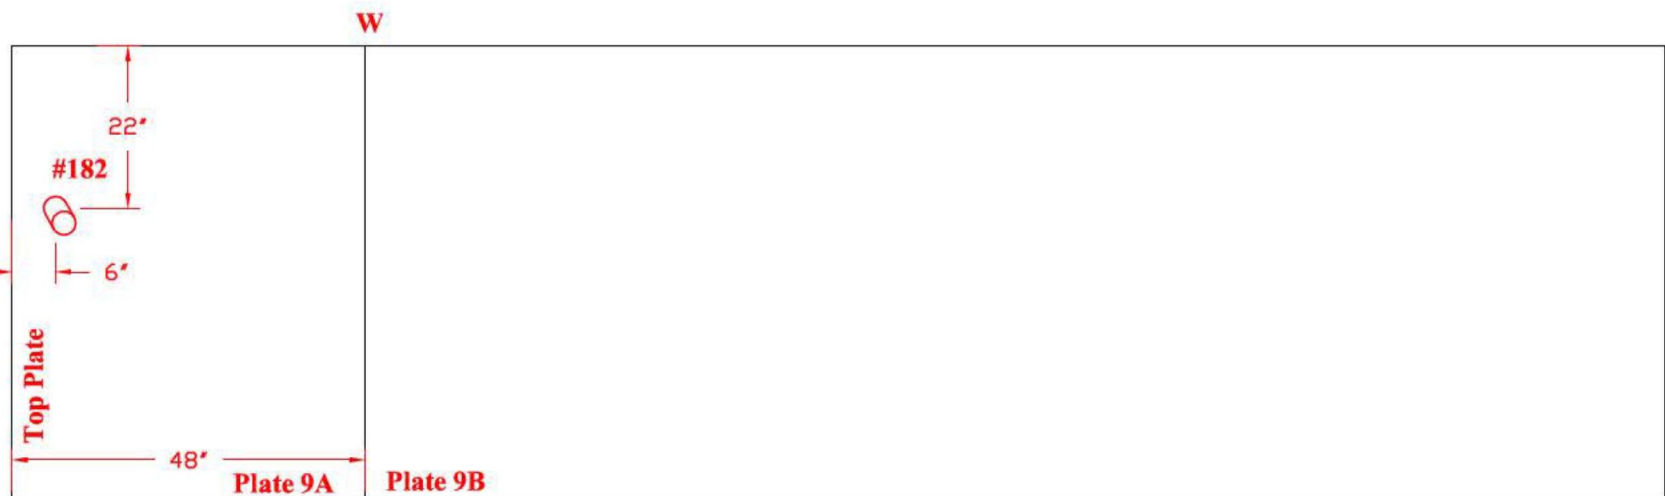
Course: 19
Plate #: 9A

Flaw # - Type - Remaining:
#182 - Grout Nozzle - 0.213"R

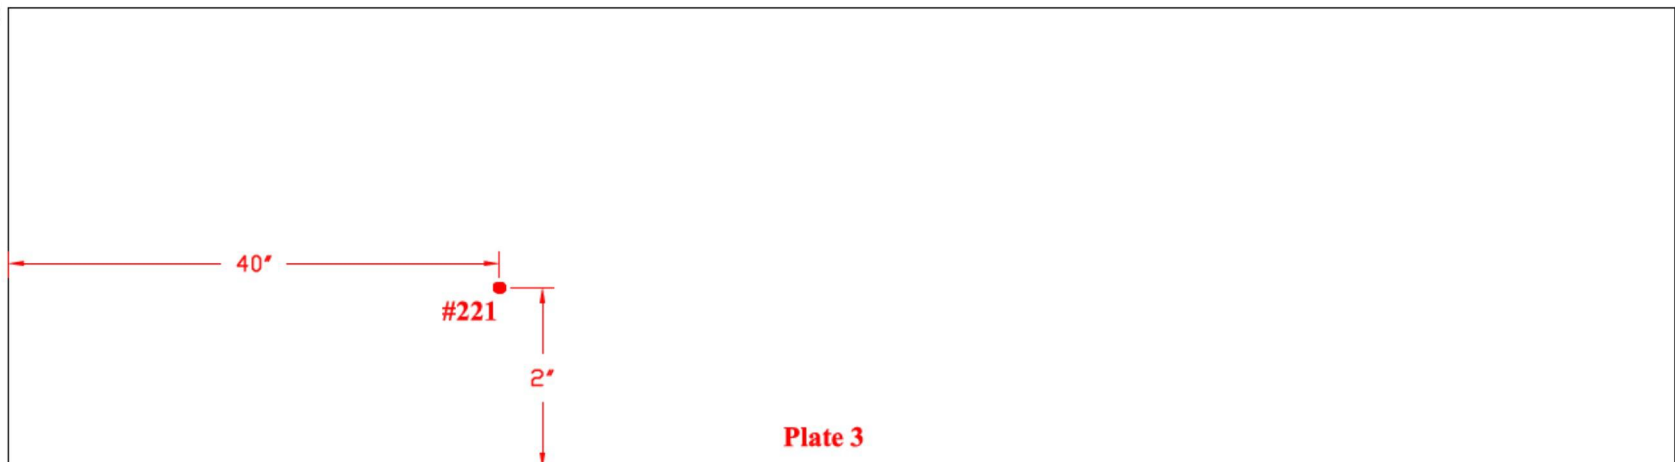
Course: 2
Plate #: 3
Flaw # - Type - Remaining:

#221 - Gouge - 0.210"Deep

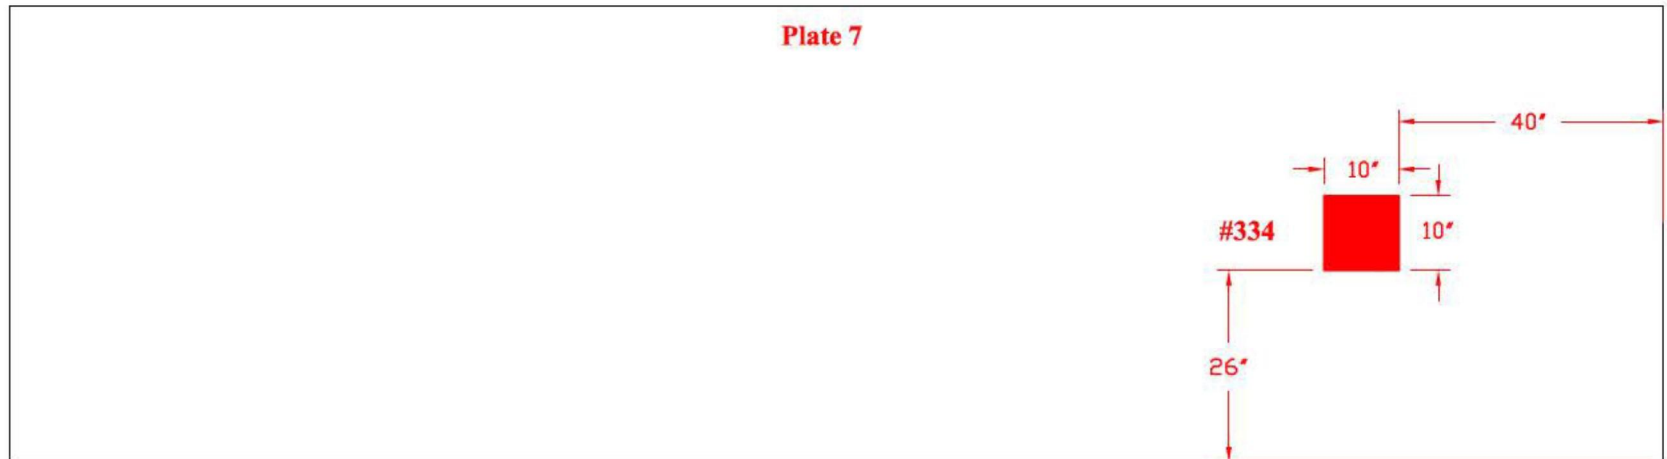
#334 - WL - 0.137"R

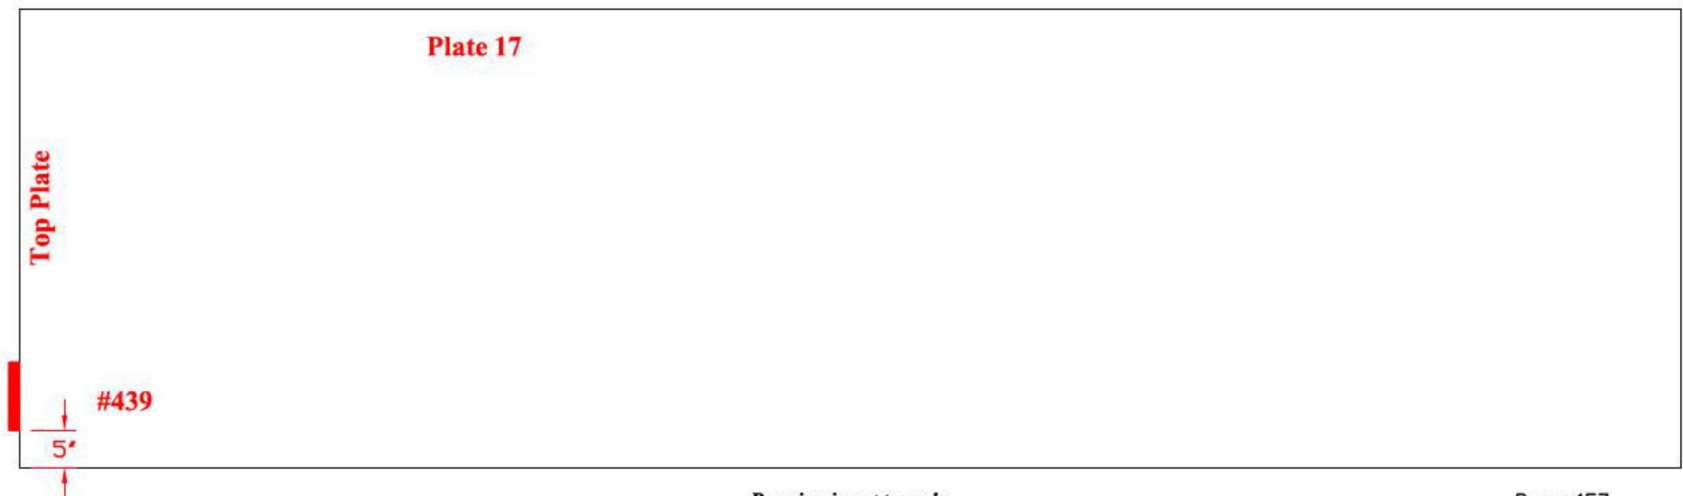
Course: D
Plate #: 17

#439 - LOF - 0.096"D 5"L

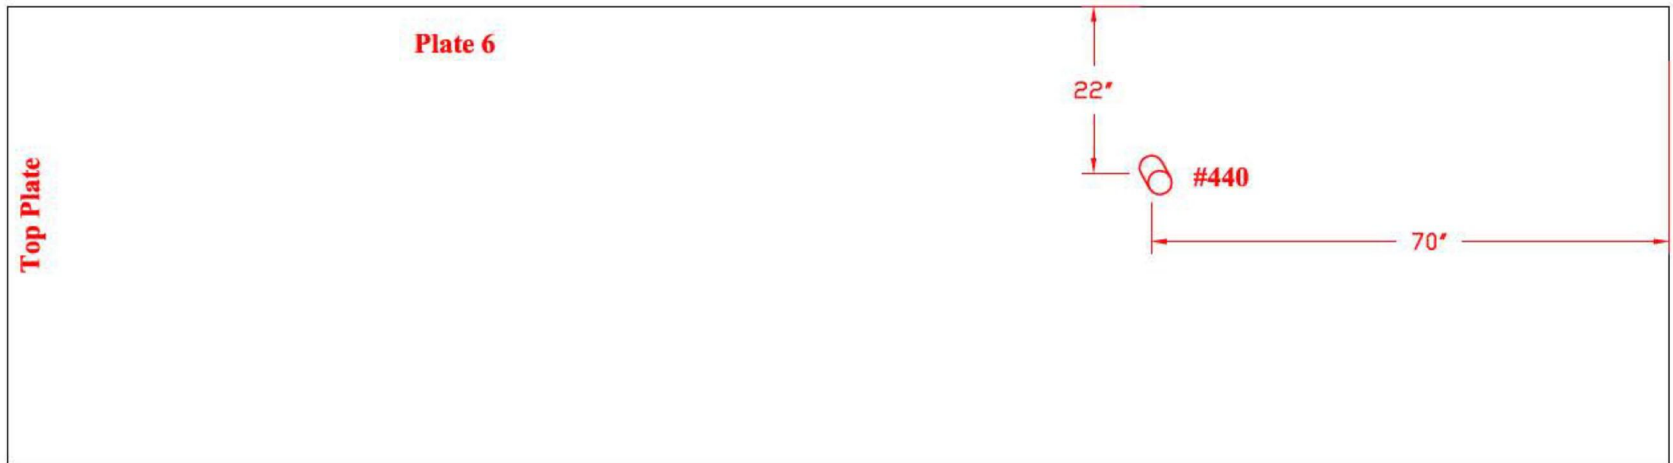
**Course: C
Plate #: 6**

#440 - Grout Nozzle - 0.230"R

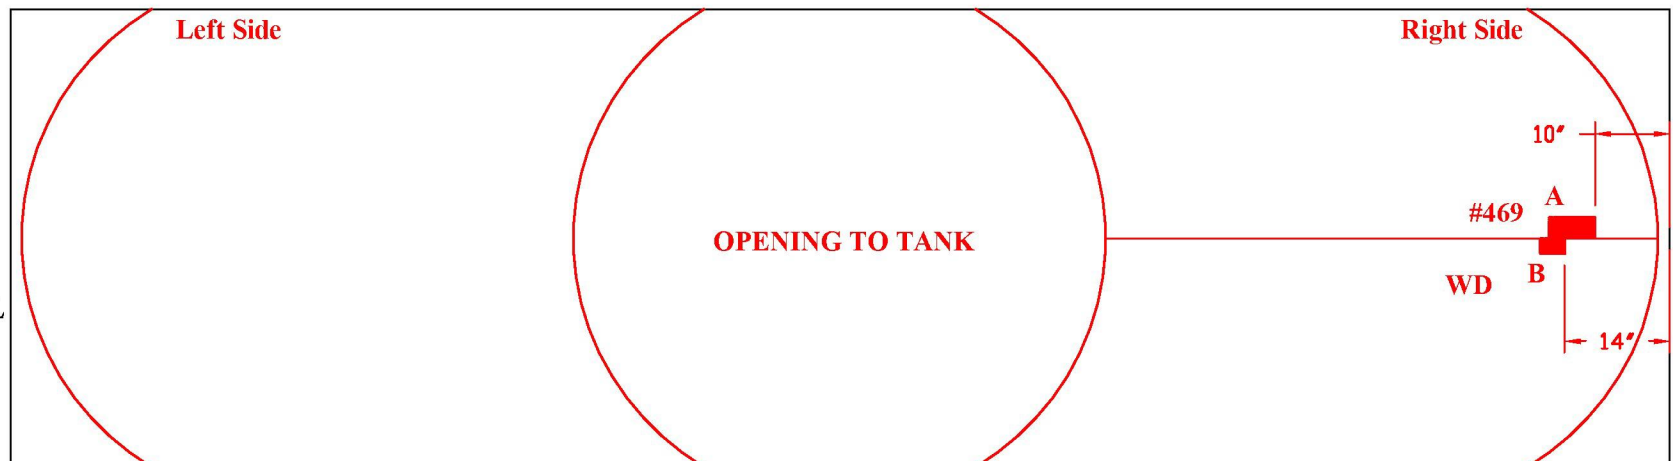
Course: 3
Plate #:
Flaw # - Type - Remaining:

#469: A)LOF - 0.136"D 5"L
B)LOF - 0.239"D 0.075"L
