**MODIFIED API-653 OUT-OF-SERVICE
TANK 20
RED HILL**

Subject: Tank No. 20 Red Hill Fuel Facility

SYNOPSIS

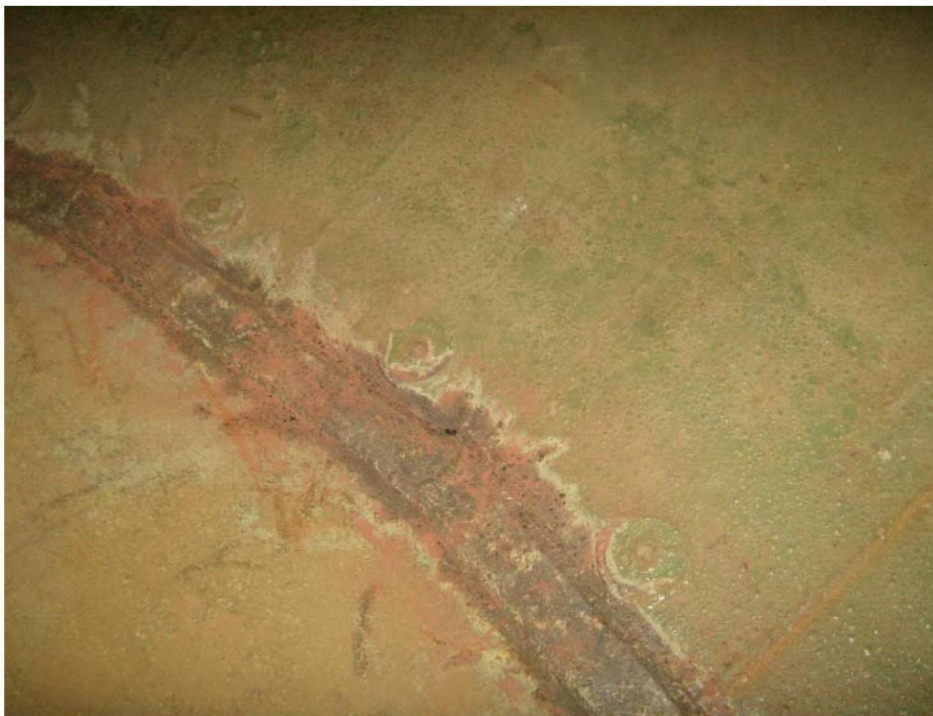
Transition from tank floor to the lower dome section

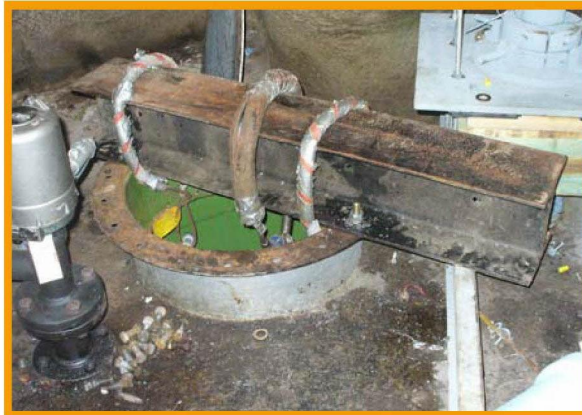
The assembly consists of three cables anchored on the top by a 42" long 8x8 I-Beam resting on a 1/4" thick top flange plate of the dome(See Image #3).

Image #3: Showing Tank #20 Spider hoist assembly top anchoring

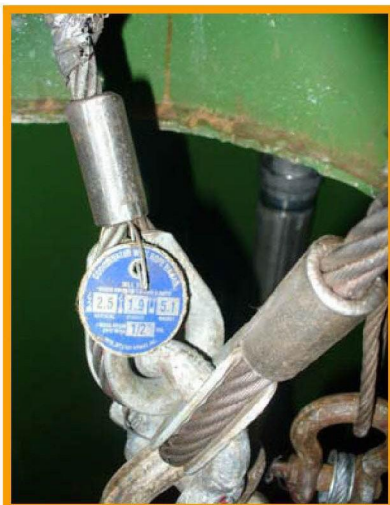
A 5/16" spider hoist cable is attached to the top anchor I-Beam with a 3/8" choke cable and 5/8" diameter shackle (attached to a 7/8 shackle). The life line cables are also 5/16" thick and attached to the top anchor I-Beam with a 5/16" choke cable and 5/8" shackles. (See Image #4)

Image #4: Showing Tank #20 Spider hoist assembly cables and shackles

The Working Load Limit of a 5/16" choke cable is 2000 pounds. The smallest shackle in the assembly holding the spider is 5/8" shackle with a Working Load Limit of 3-1/4 ton, or 6,500 pounds. The cable bends and shackles reduce the Safe load another 50%. Therefore, a safe

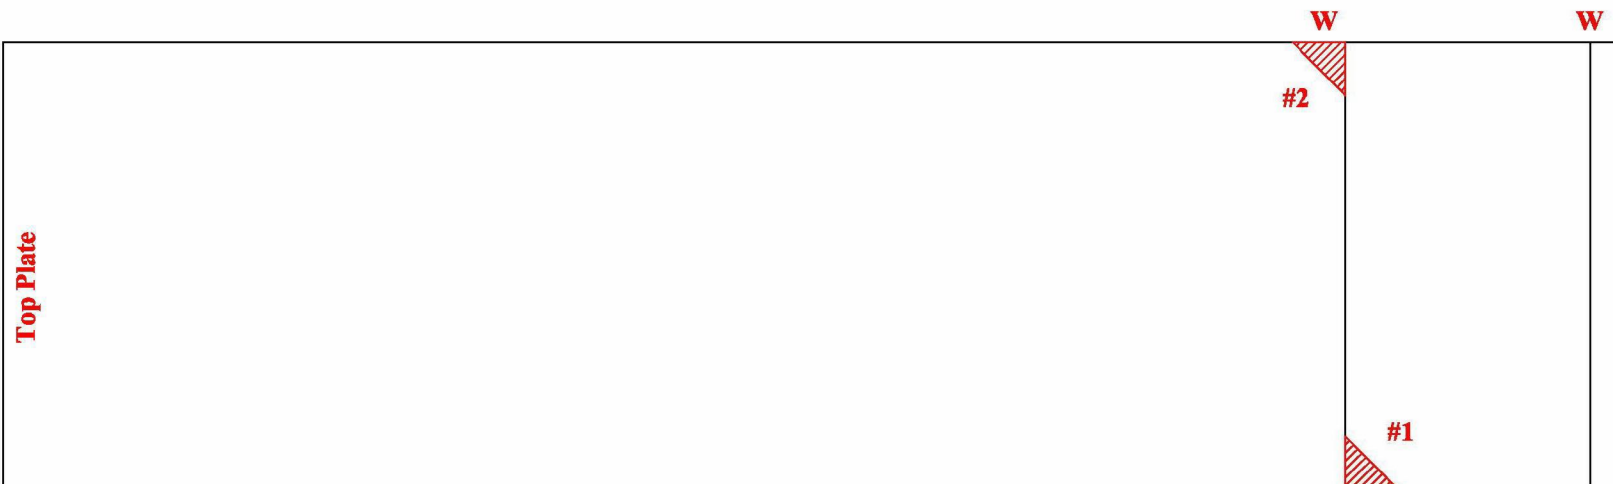
Tank Section: Lower Dome
Quadrant: A

Course: 1
Plate #: 3

Flaw # - Type - Remaining:

#3 -Wall Loss (corner) - 0.240"R

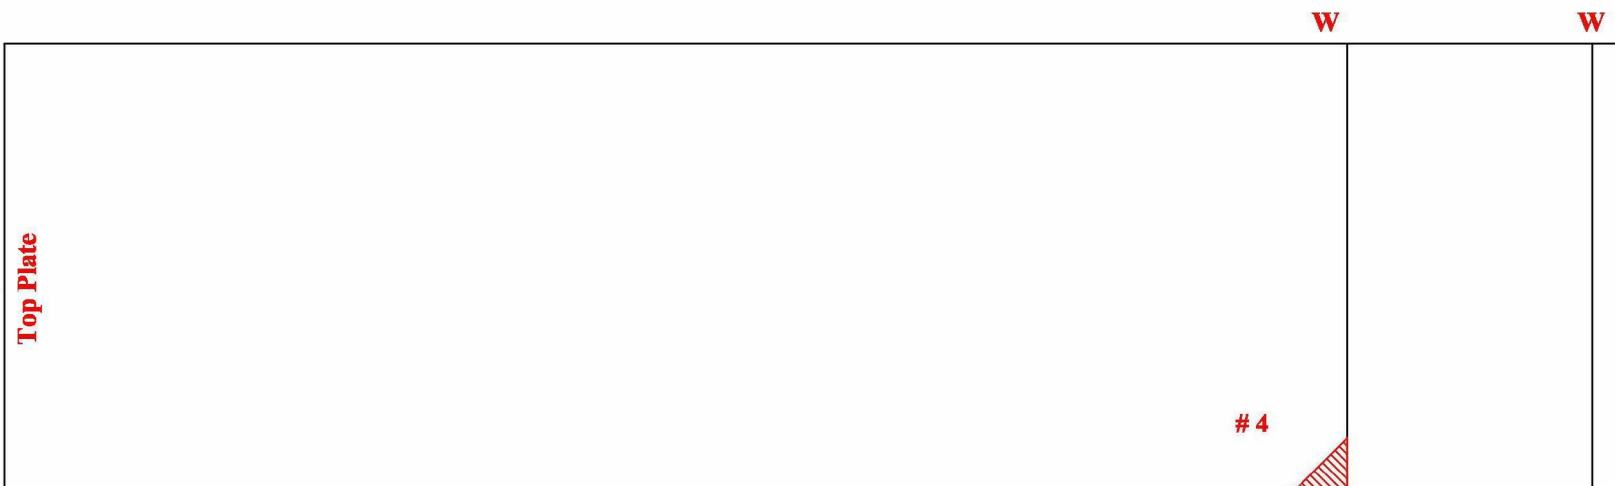
Tank Section: Lower Dome
Quadrant: A

Course: 1
Plate #: 6

#6 -Wall Loss (corner) - 0.240"R

#7 -Wall Loss - 0.240"R

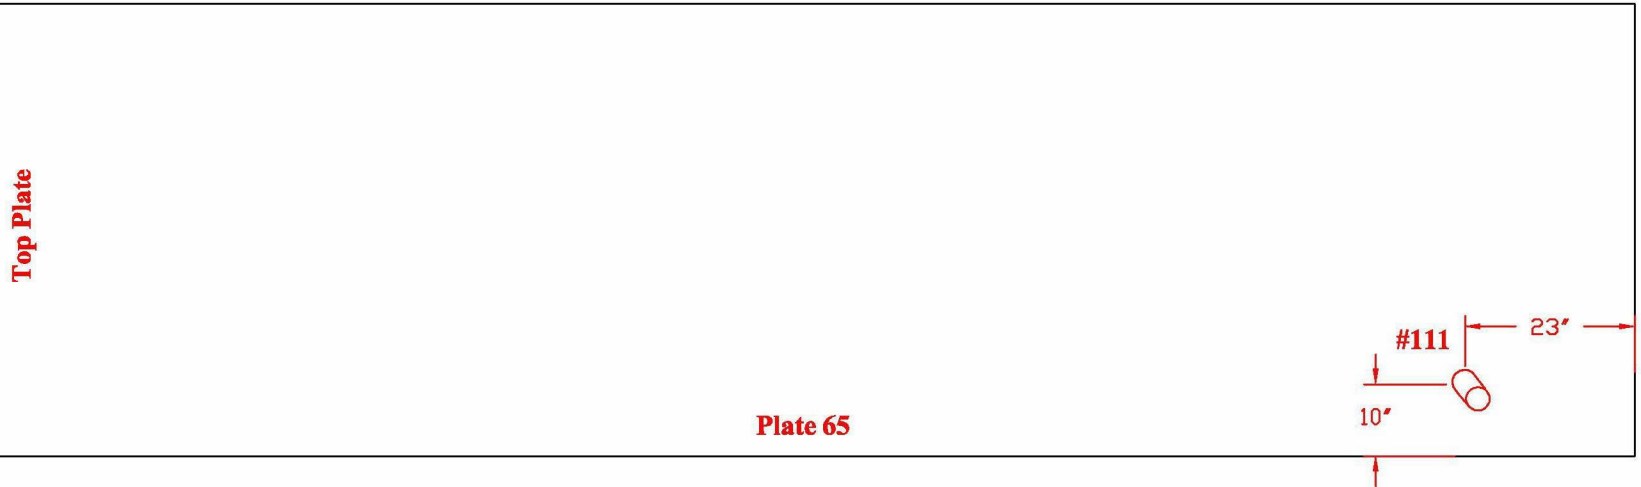
Course: 4
Plate #: 65
Flaw # - Type - Remaining:

#111 - Grout Nozzle - 0.228"R

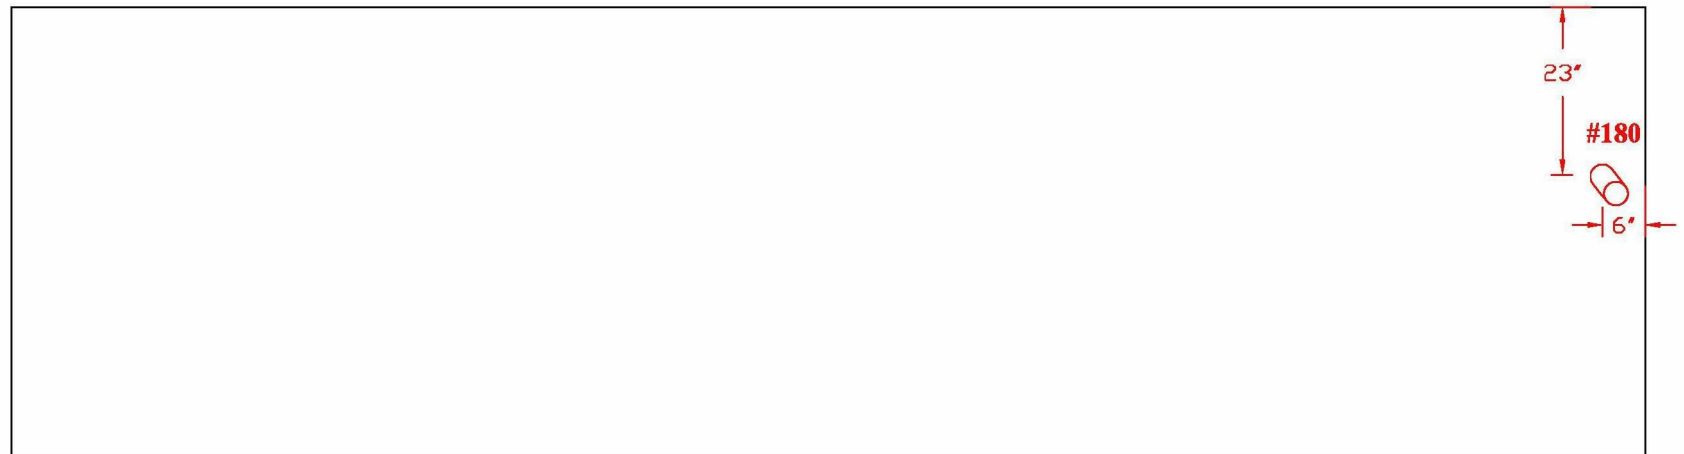
Course: 27
Plate #: 8
Flaw # - Type - Remaining:

#180 - Grout Nozzle - 0.203"R

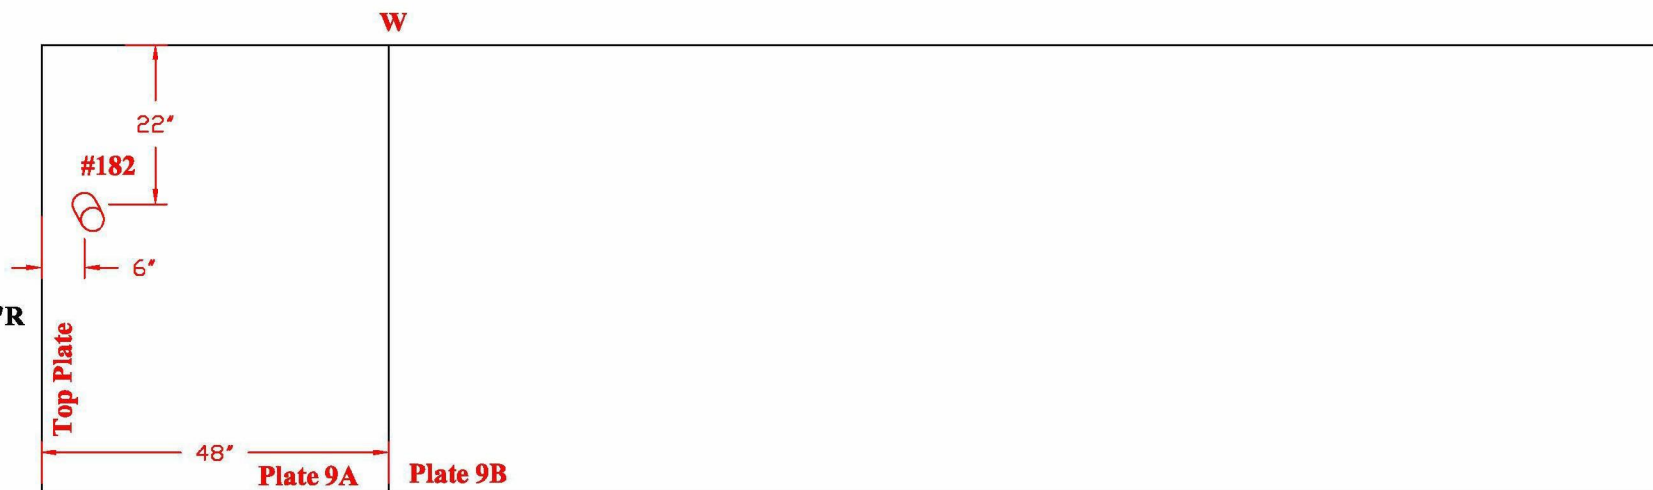
Course: 19
Plate #: 9A

#182 - Grout Nozzle - 0.213"R

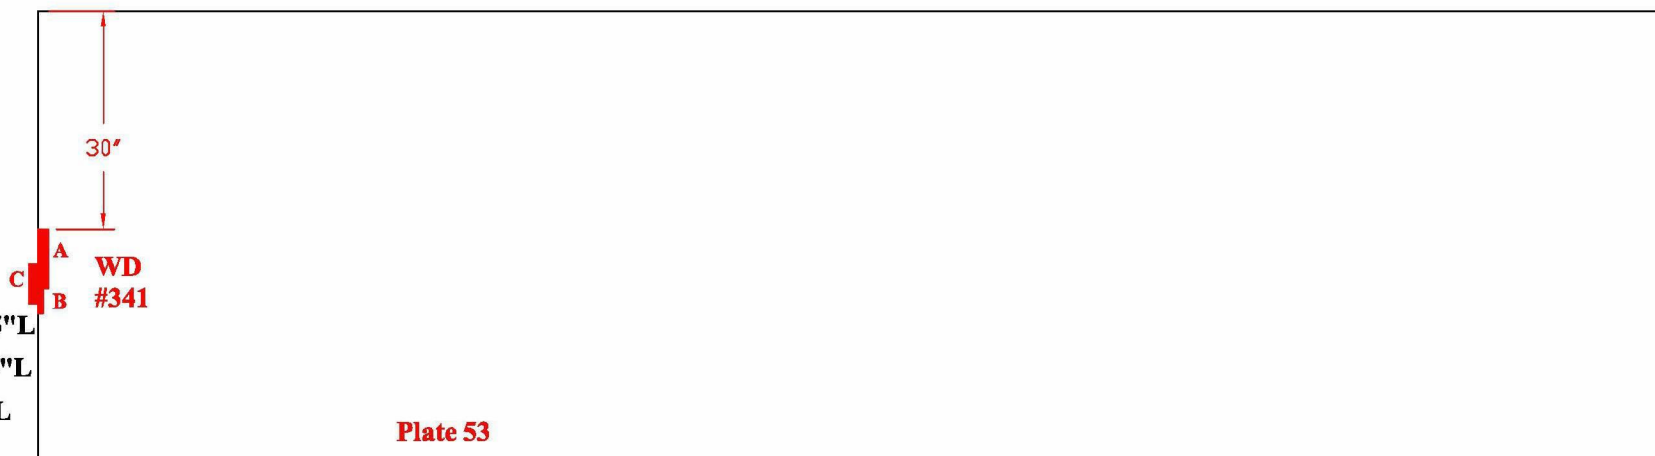
Course: B
Plate #: 53
Flaw # - Type - Remaining:

#341: - A) LOF - 0.083"D 6.5"L
B) LOF - 0.217"D 1.5"L
C) LOF - 0.064"D 7"L

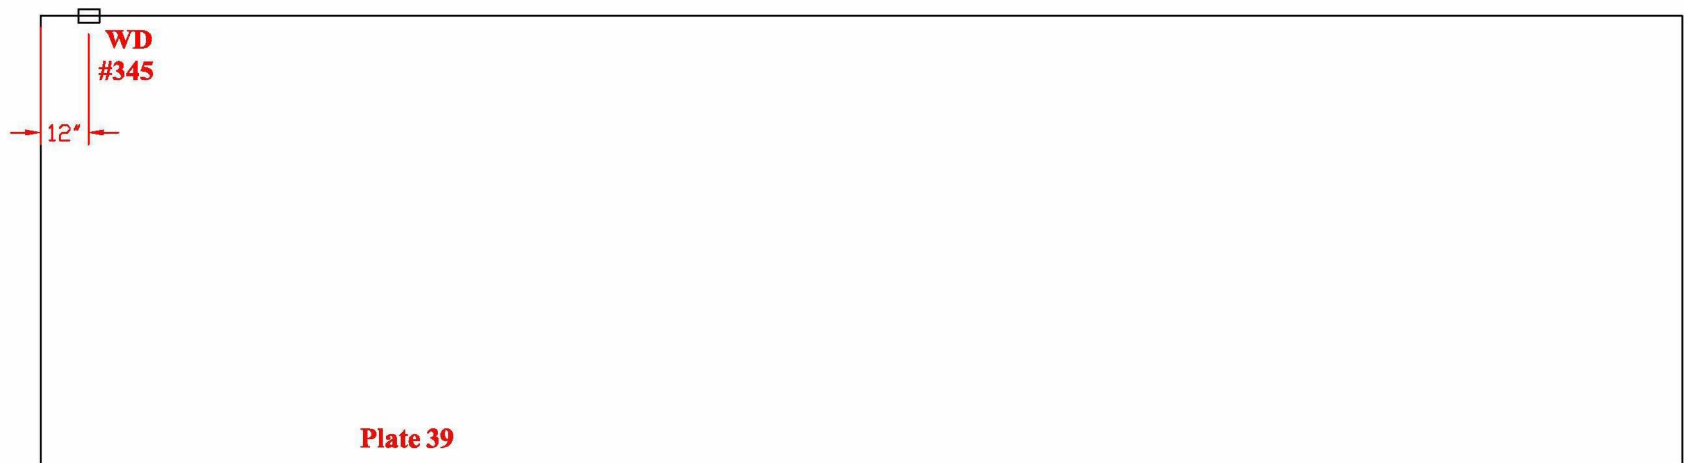
Course: B
Plate #: 39
Flaw # - Type - Remaining:

#345 - LOF - 0.169"D 3"L

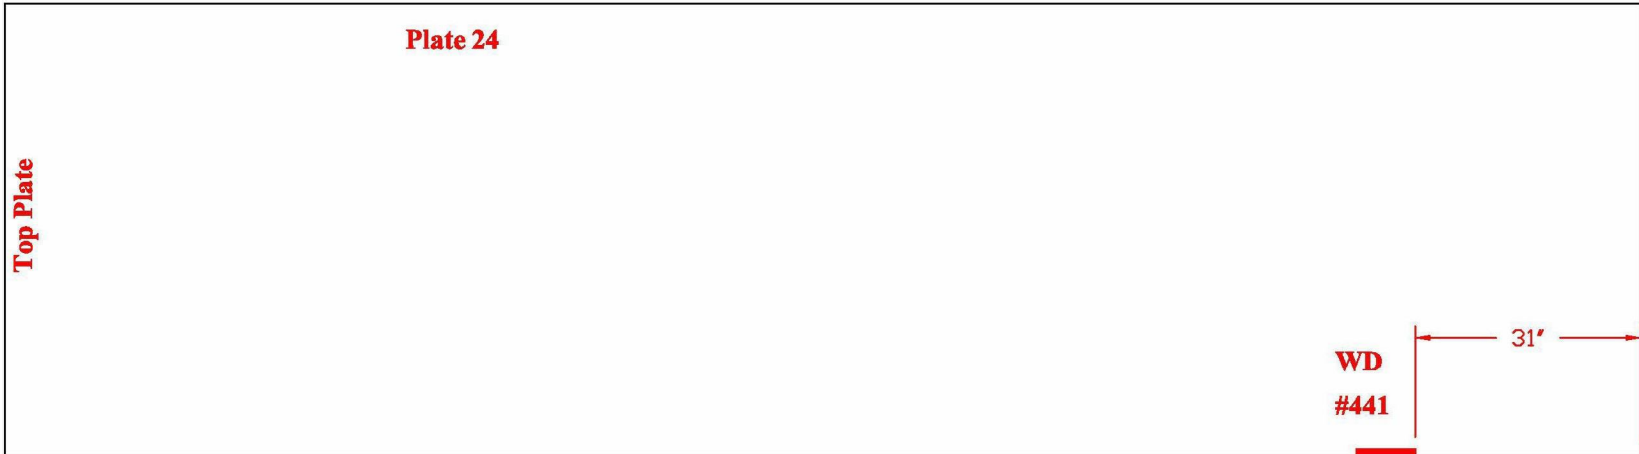
Course: D
Plate #: 24

#441 - LOF - 0.110"D 6"L

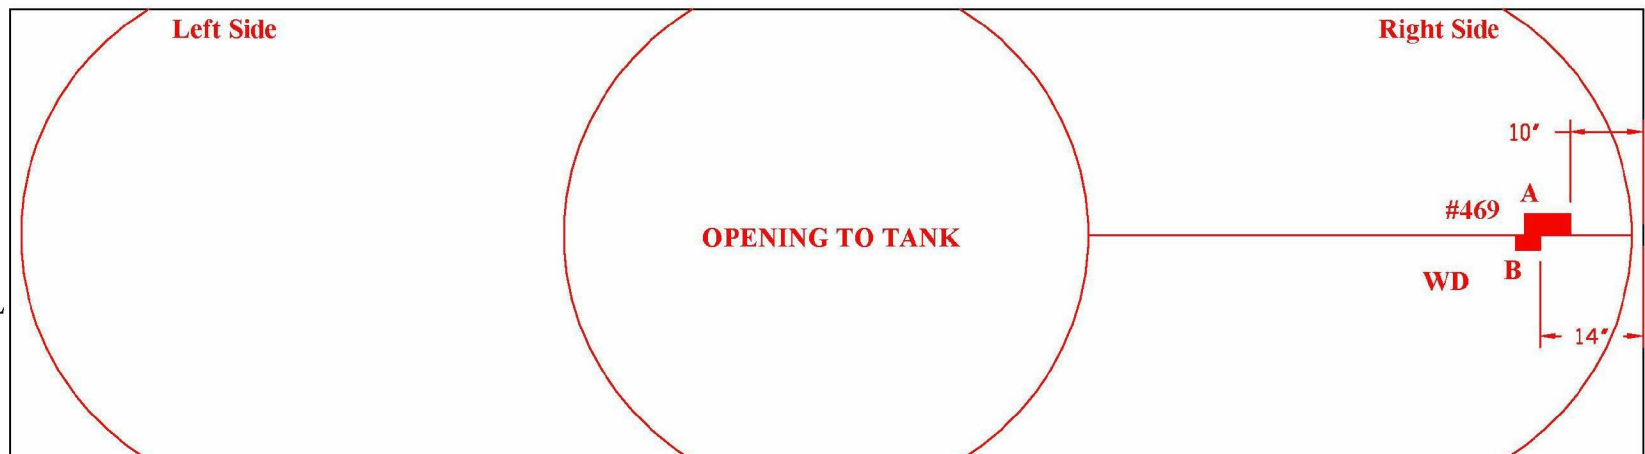
Course: 3
Plate #:
Flaw # - Type - Remaining:

#469: A)LOF - 0.136"D 5"L
B)LOF- 0.239"D 0.075"L

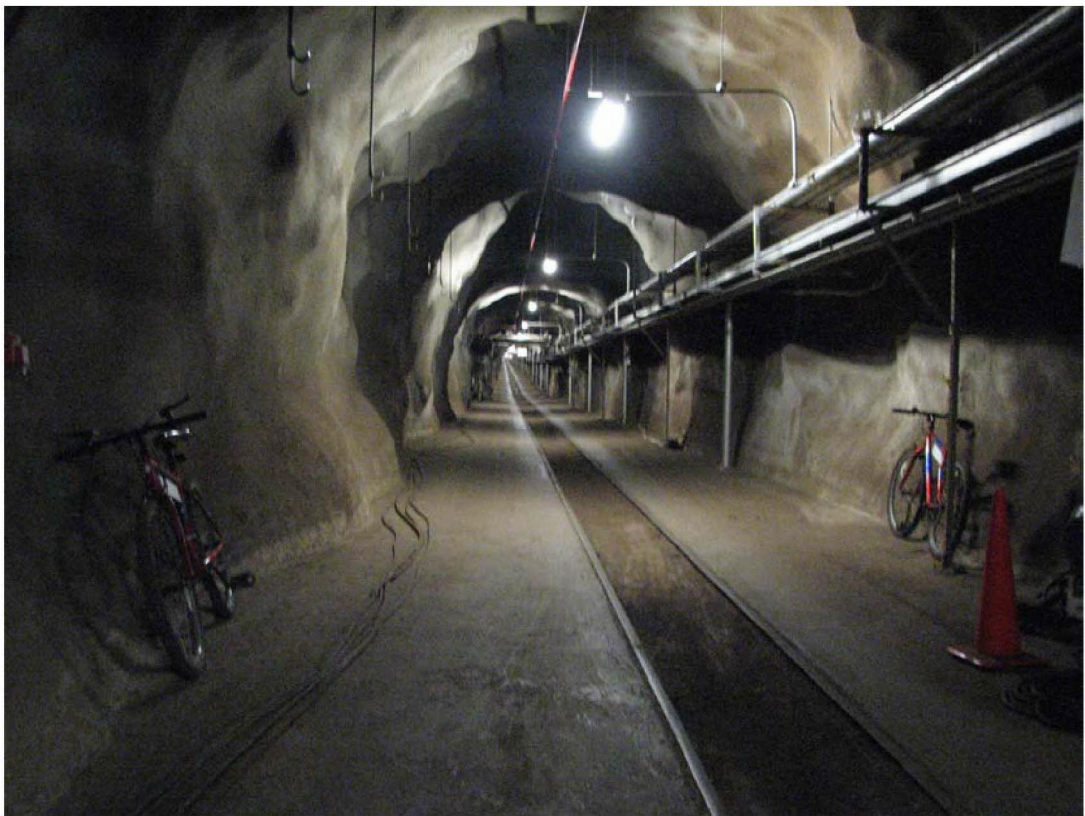
A view of the tunnel area around tank #2.

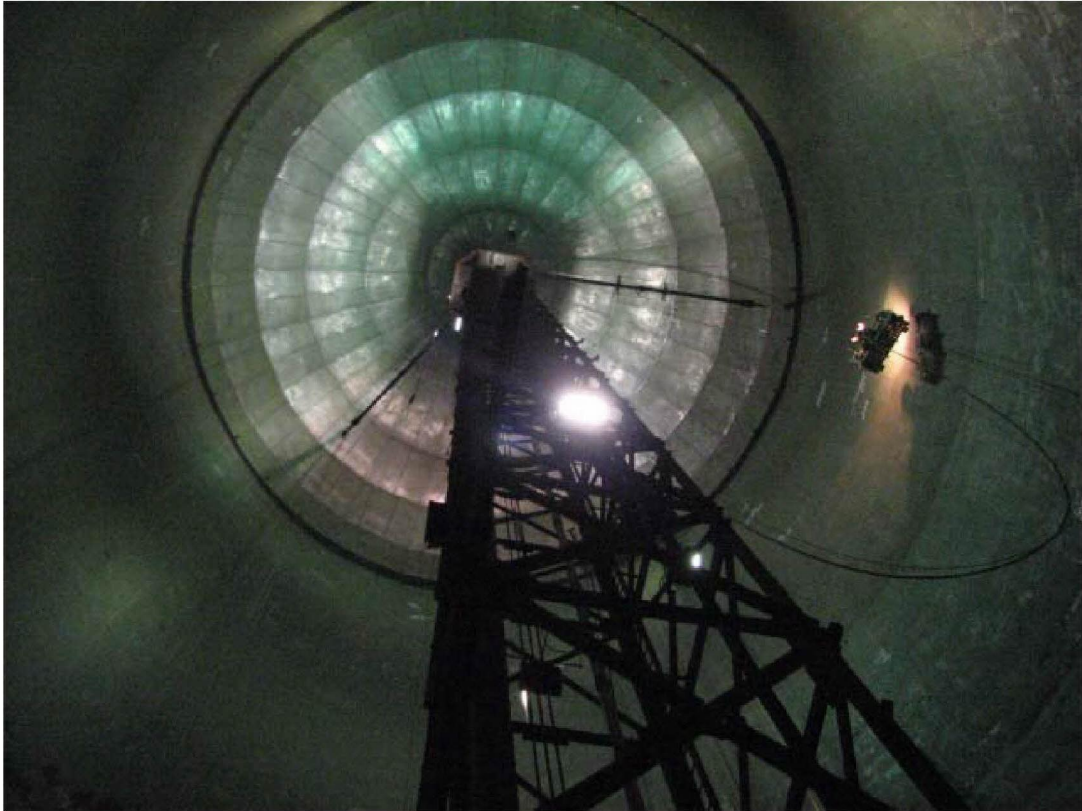
A view from the tank bottom of one of the teams scanning the barrel

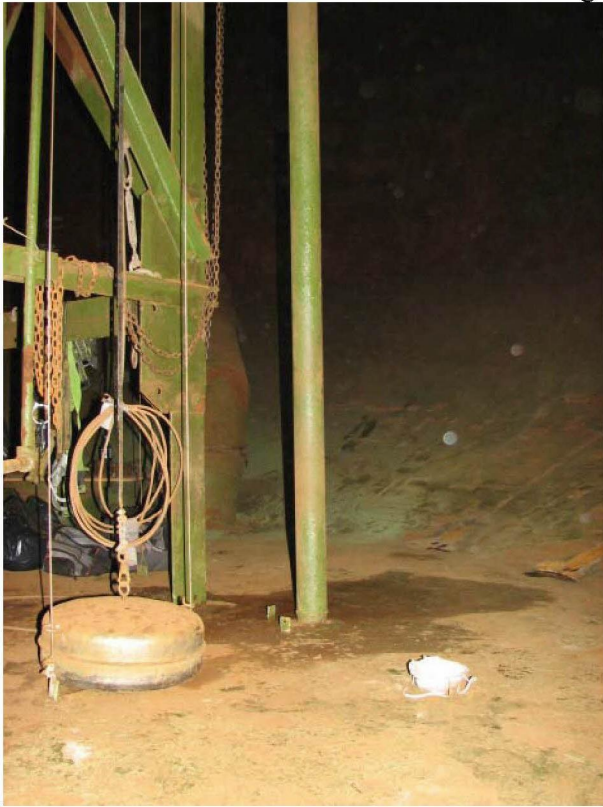
Picture showing part of the floor and lower dome

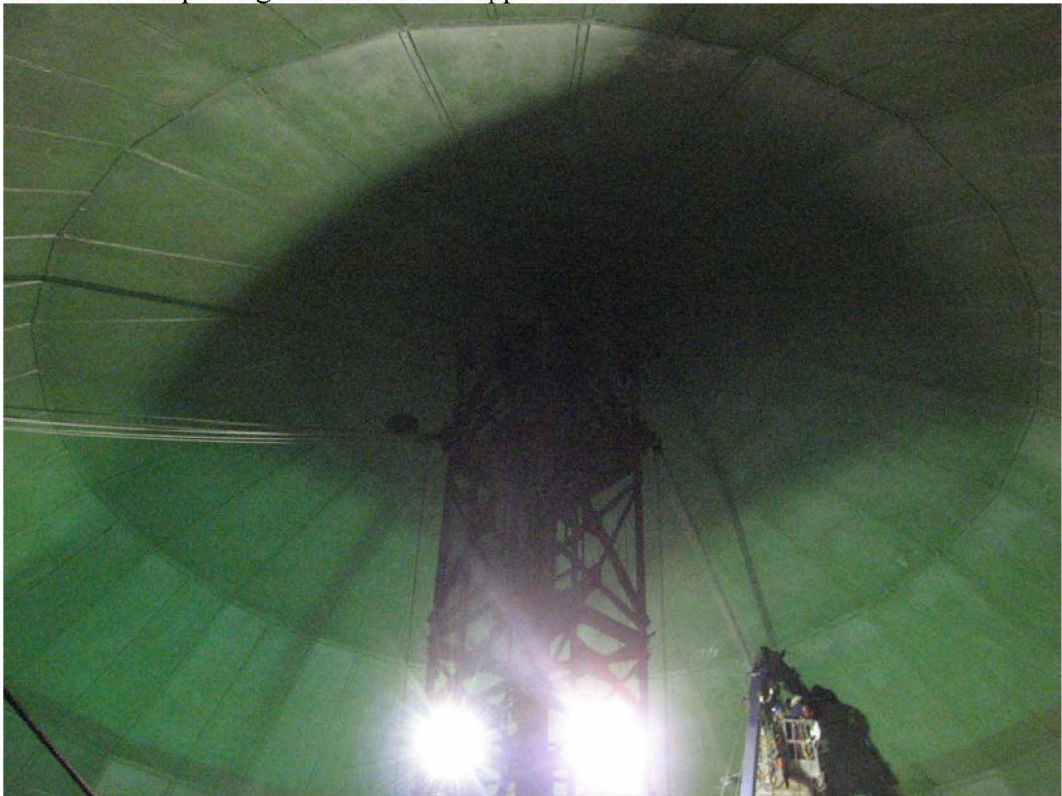
A view of the very top of tank # 2 showing courses D, E, and F with a TesTex crew
