TANK 5 API 653 OUT-OF-SERVICE INSPECTION AND SUITABILITY FOR SERVICE EVALUATION FINAL CONDITION ASSESSMENT REPORT (PRE-REPAIR)

Joint Base Pearl Harbor-Hickam, HI (JBPHH)

August 20, 2020

Date of Inspection: October 2017 - January 2018

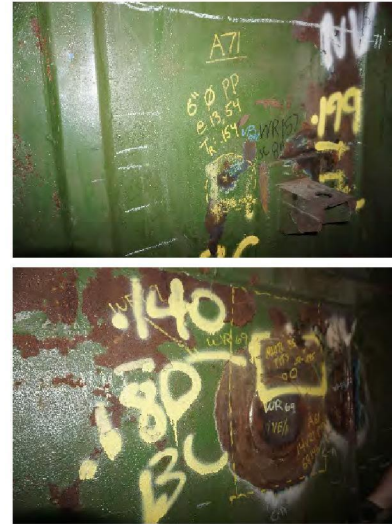
Table 5-1 Mandatory Repairs		
Finding	Repair	Photo
Mandatory repairs are repairs that are critical to the hydraulic and structural integrity of the tank and are required to return the tank to service.		
1. Defects found requiring patch plate repairs are: <ul style="list-style-type: none"> • Backside Corrosion • Dents 	Provide patch plate repairs. Plate size, location in tank, and overall quantities can be found in Attachment F.

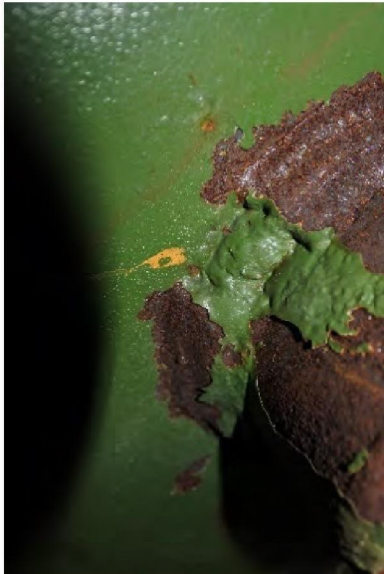
Finding	Repair	Photo
<p>3. Defects found requiring weld repairs are:</p> <ul style="list-style-type: none"> • Weld Indications • Porosity/Rounded Indications • Lack of Fusion • Insufficient Fill • Gouges • Undercut • Other shell topside indications 	<p>Provide weld to repair defects. Weld length, location in tank, and overall quantities can be found in Attachment F.</p>

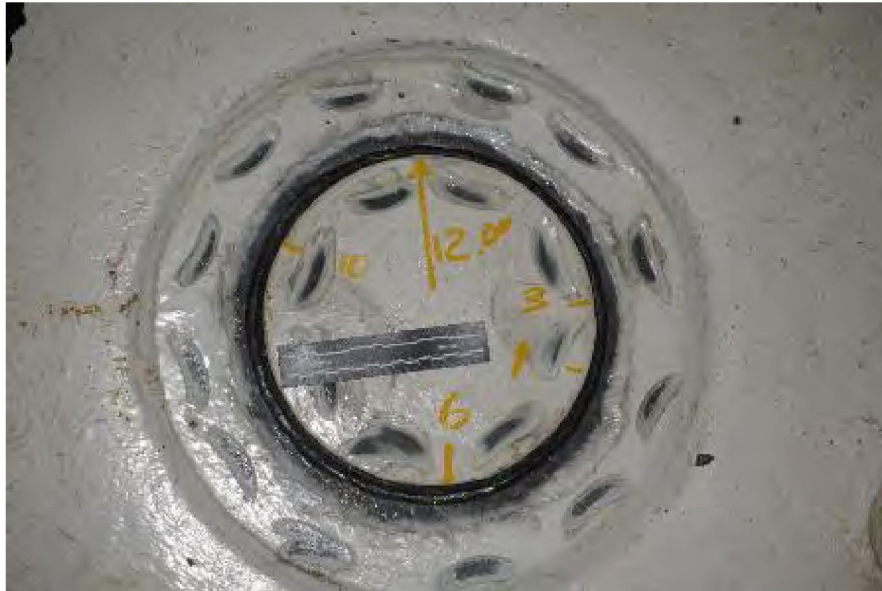
<p>4. The 8-inch drain line cover plate had 4 linear weld defects. The defects were found at the 3, 4, 6 and 10 o'clock positions and were approximately 1/8-inch in length.</p>	<p>Grind out defects and provide weld repair.</p>

Photo 7: Tank Drain Line Cap
(Note: Indications found with Magnetic Particle Testing).

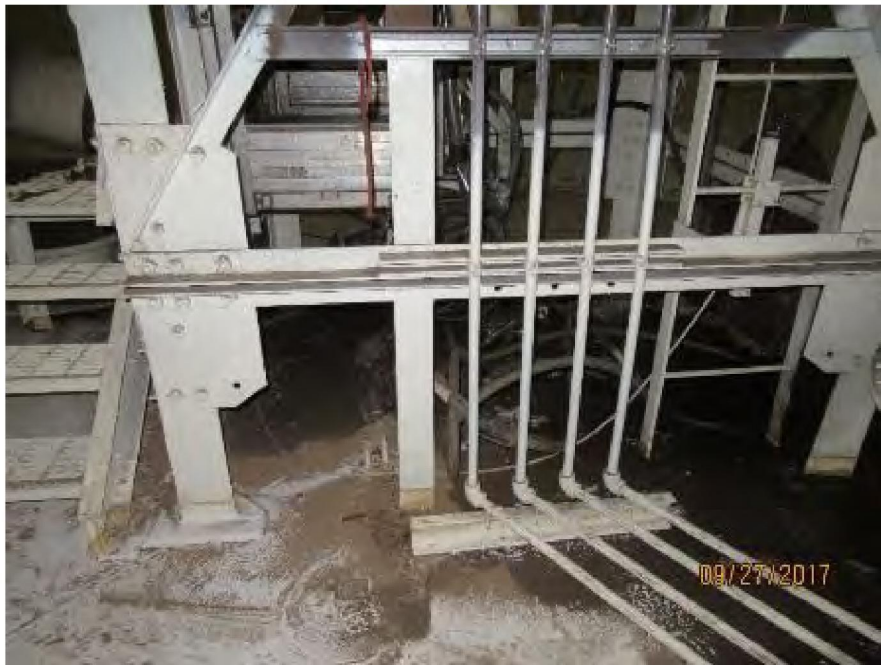
Photo 10: Sample Lines
(Note: Supports not seal welded to tank floor).

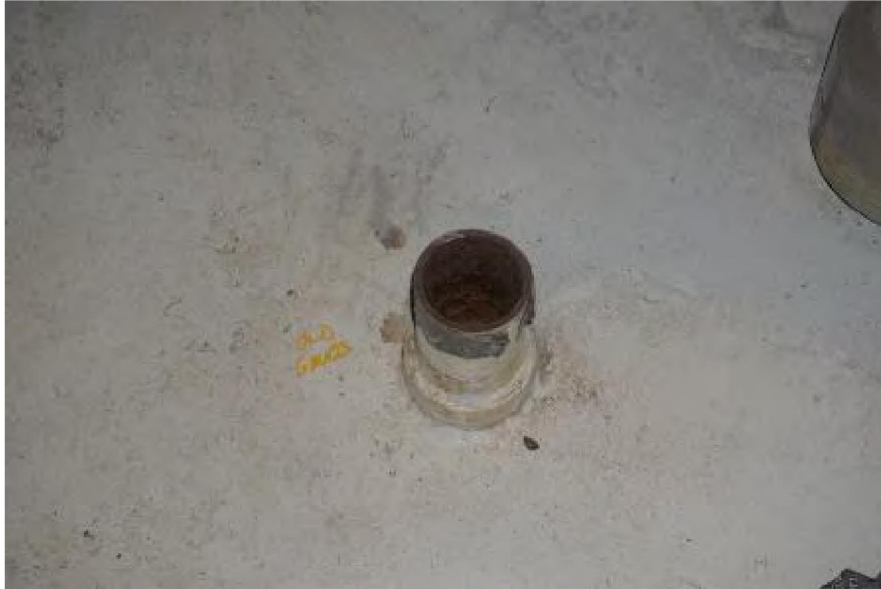
Photo 11: Old stilling well still welded to floor

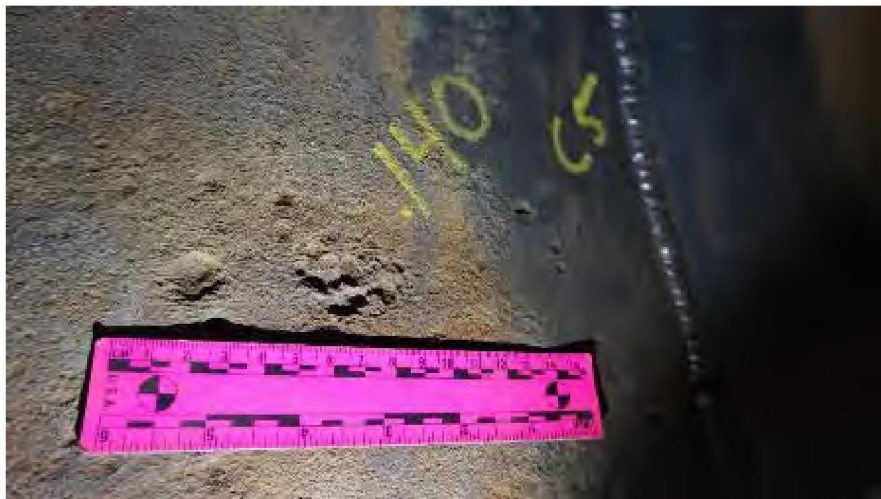
Photo 16: 32-inch piping interior pitting

Table 5-3 Repairs For Long Term Serviceability		
Finding	Repair	Photo
2. The inside of the 32-inch line is not currently coated.	Once the 32-inch line is repaired, coat the inside of the line with Polysulfide modified Epoxy Novolac coating system used for lower dome coating. By doing so the line will be subject to less corrosion potential.

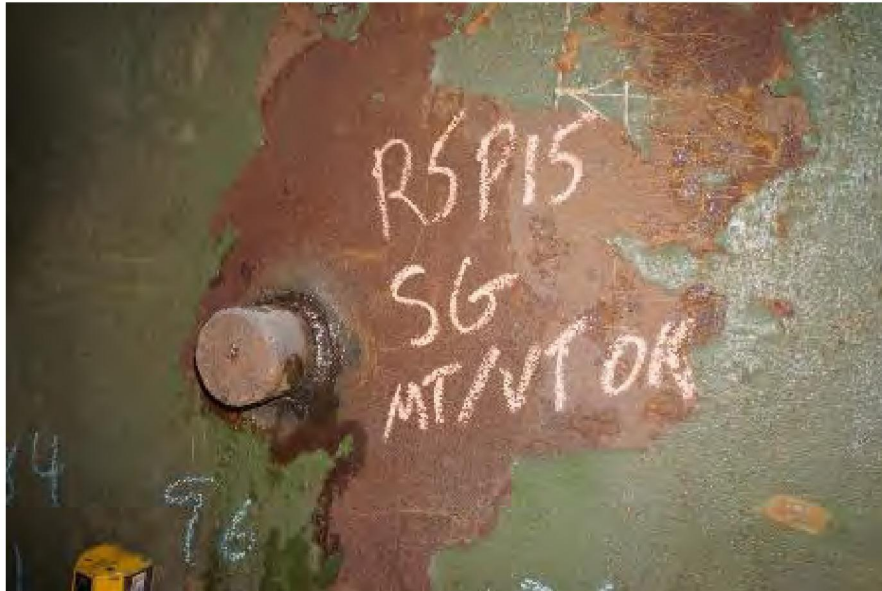
Photo 27: Barrel Strain Gauge Pipe Cap

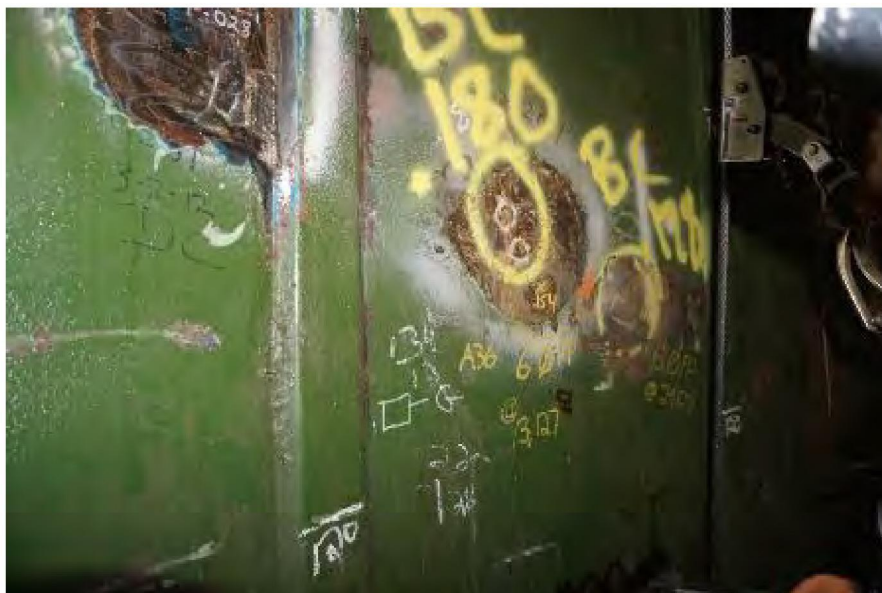
Photo 28: Backside Corrosion on existing ground areas

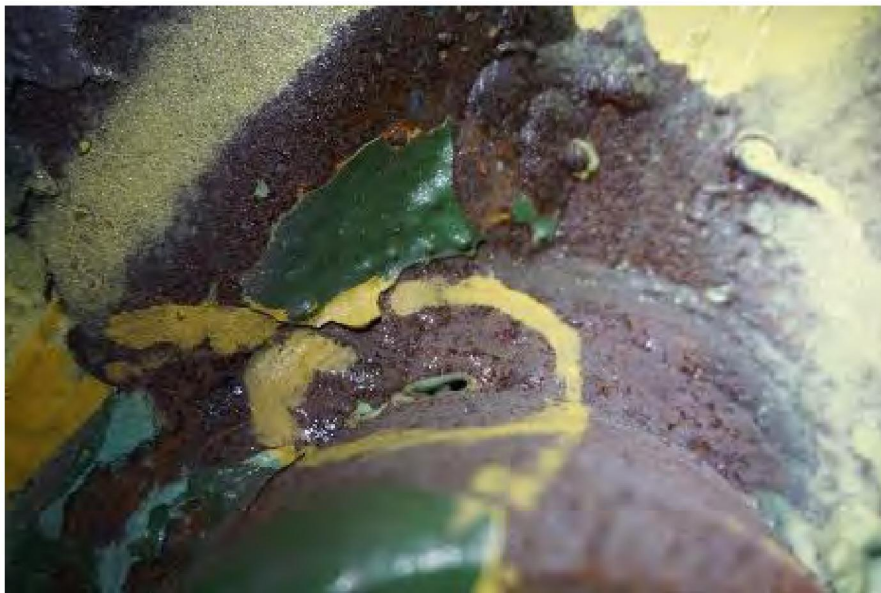
Photo 36: Rounded Indication

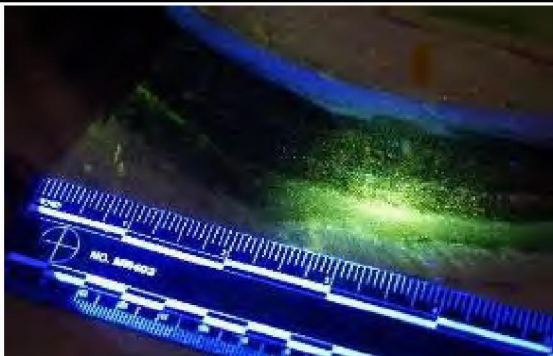
R	1/8" LT	Grind out and re-weld if need be	
N/A	6:00

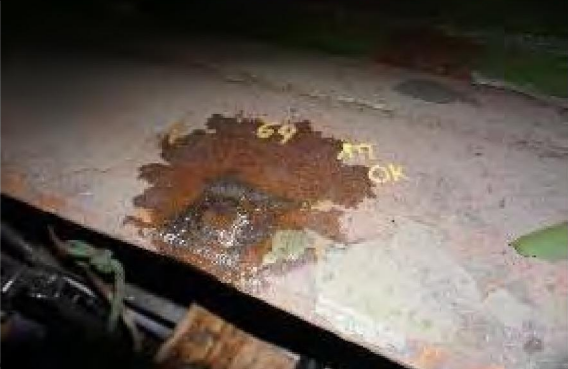
A	N/A	NR	
TK5-PW-64	EXPANSION JOINT

A	N/A	NR

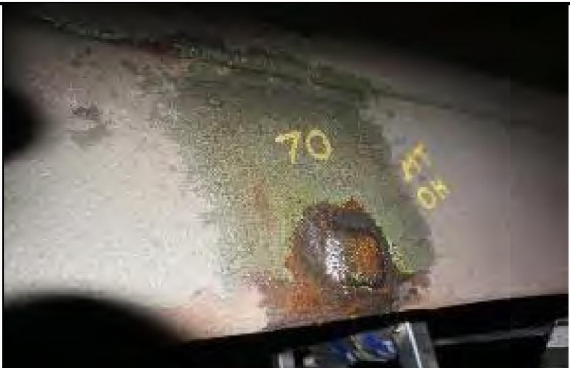
TK5-PW-70	EXPANSION JOINT

A	N/A	NR	
TK5-PW-71	EXPANSION JOINT

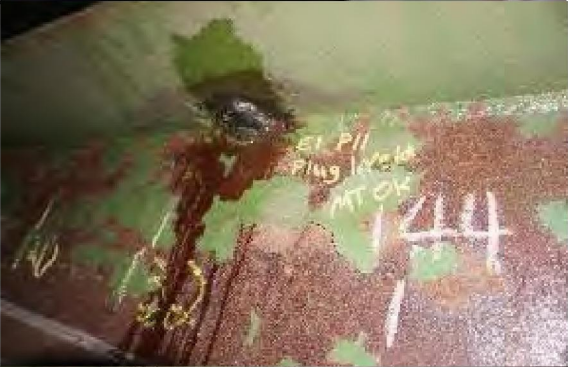
R	Multiple L W Cracks	Grind and Re-weld 6" WR	Located on E1 P9
TK5-PW-121	Adjustment Plate

A	N/A	NR	
TK5-PW-139	Adjustment Plate

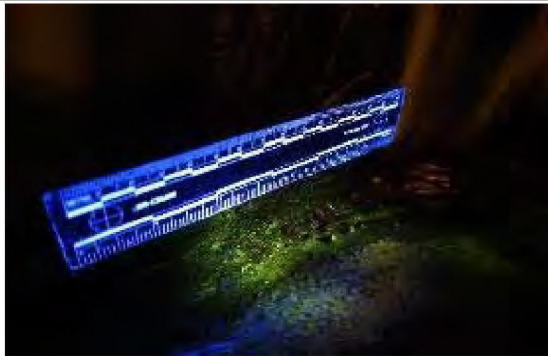
A		Visual examination found UF and UC present	
5-UD-A-17-31-0	A17

A		Grind out and re-weld failed on visual	
5-UD-A-18-0-0	A18

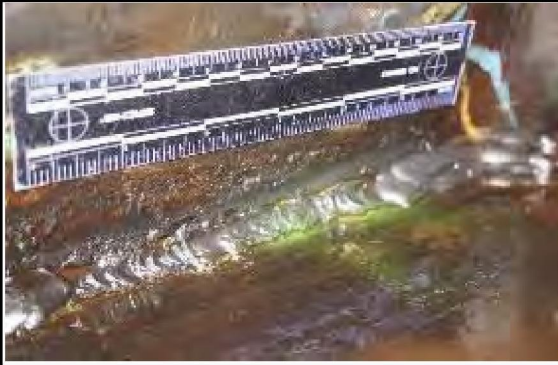
5-UD-A-18-26-0	A18

A		Grind out and re-weld failed on visual	
5-UD-A-20-10-0	A20

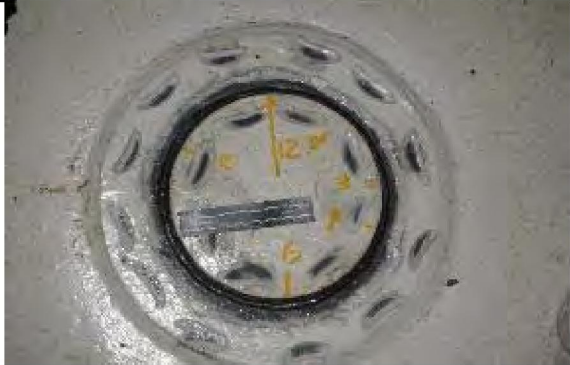
ID #	Location	Photos	VBT Results	Indication info	Repair Details	Extra Comments
TK5-8"DC	Floor

A	N/A	Grind out and re-weld if need be	Repair due to failed MT
Glossary						
R: Reject A: Accept NR: No Repair N/A: Not Applicable NRI: No Reported Indications

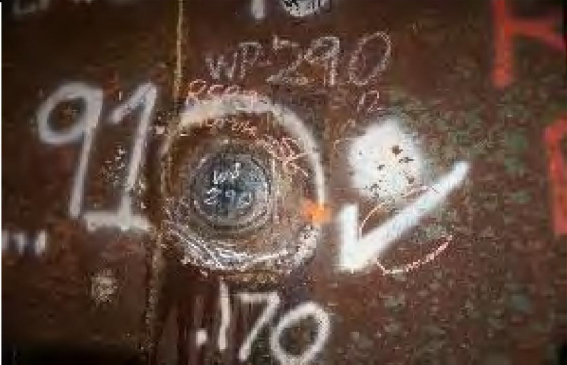
ID #	Location	Photos	VBT Results	Indication info	Repair Details	Extra Comments
TK5-SG-R5P3	R5P3

N/A	N/A	NR	Already VBT under WGS warrenty work
TK5-SG-R5P7	R5P7

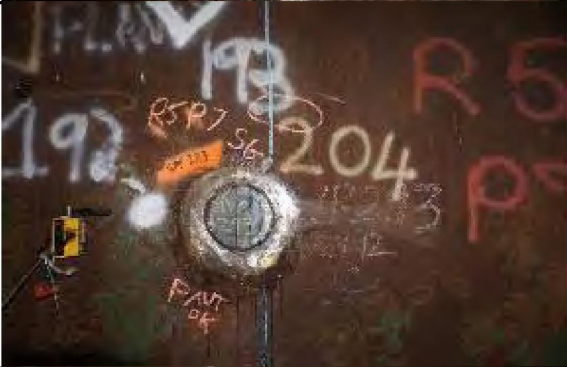
N/A	N/A	NR	Already VBT under WGS warrenty work
TK5-SG-R5P11	R5P11
