Joint Task Force-Red Hill

Bi-Monthly Quality Validation Working Group Meeting

22 June 2023

Red Hill Bulk Fuel Storage Facility Defuel

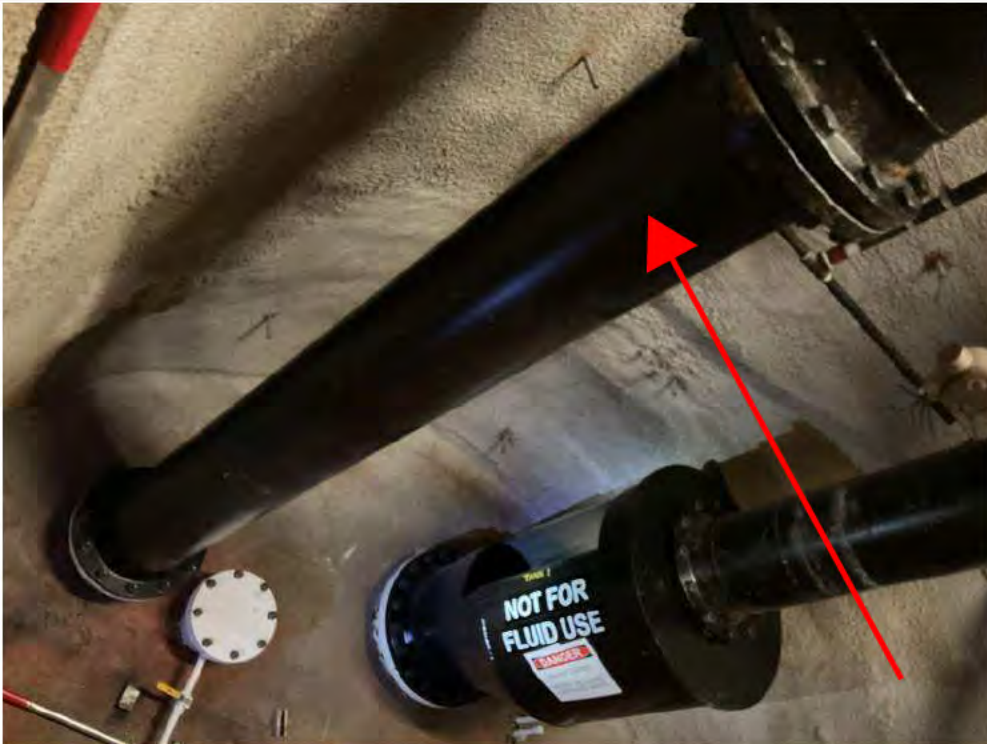
line (top of photo).

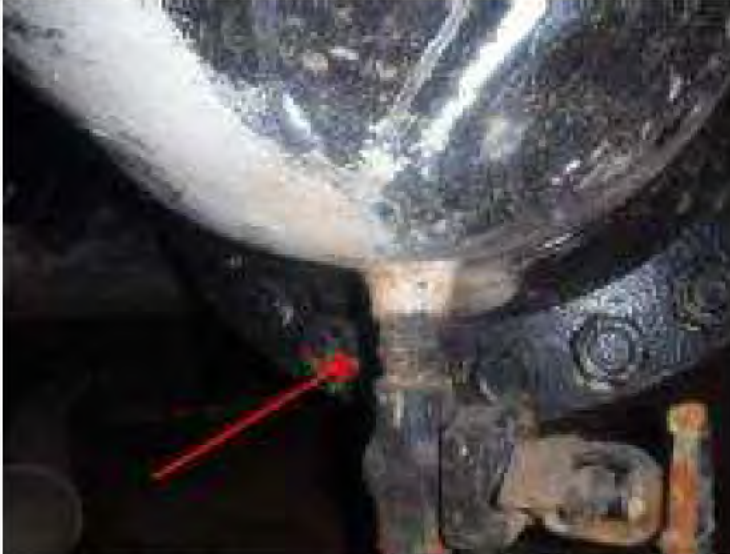
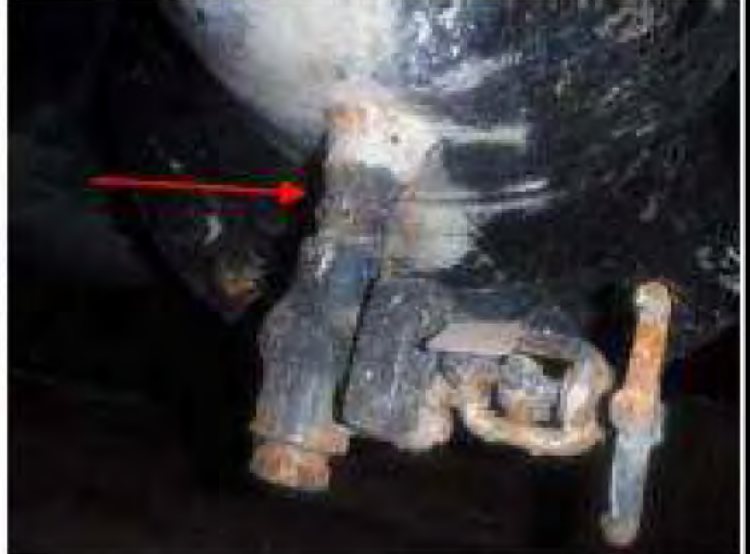
Existing low point drain assemblies in need of service.

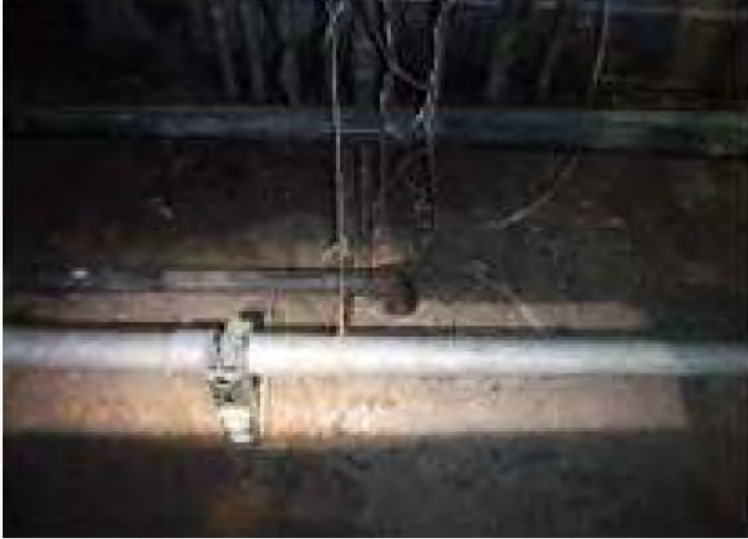
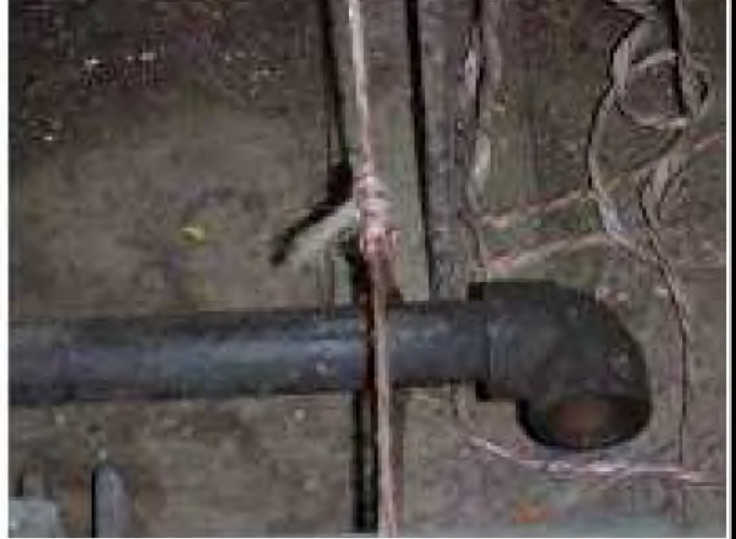
Existing condition (b) (3) (A) line unplugged

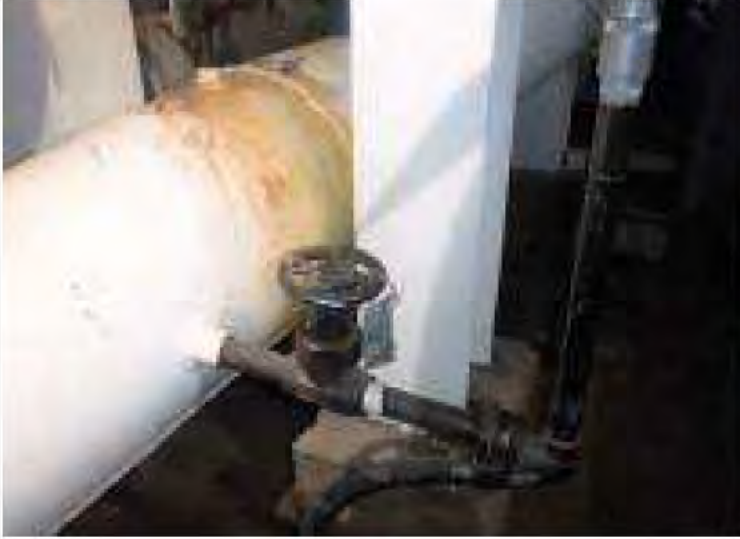
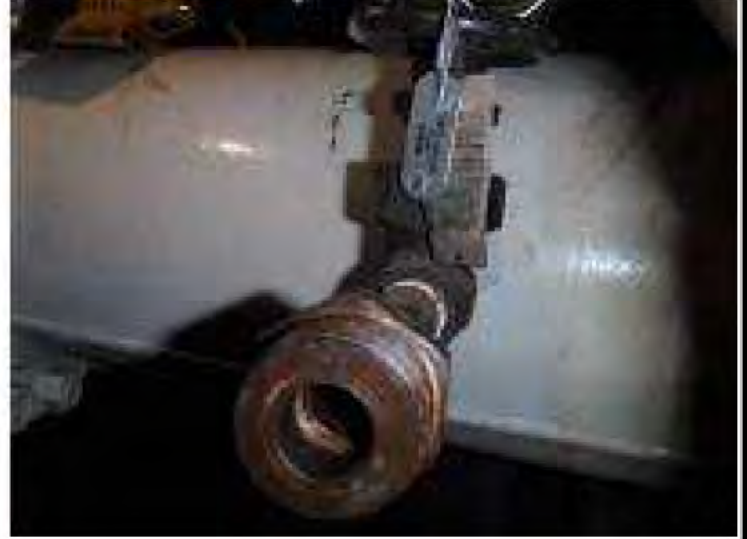
Existing condition: no plug/cap on pipeline nipple.

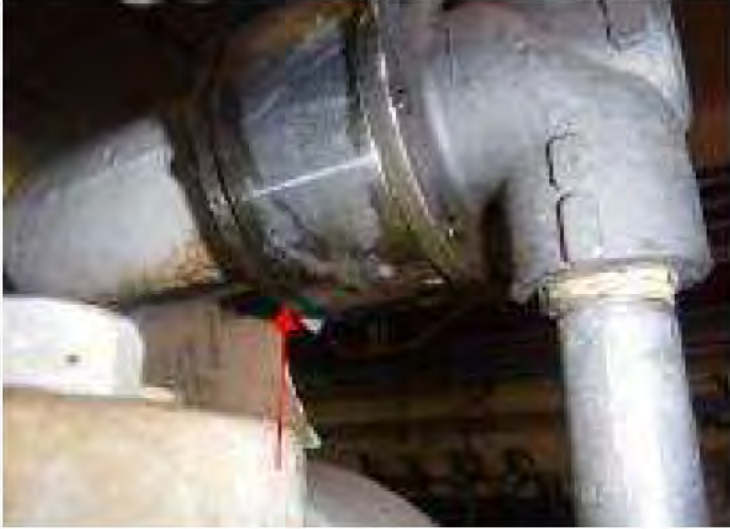
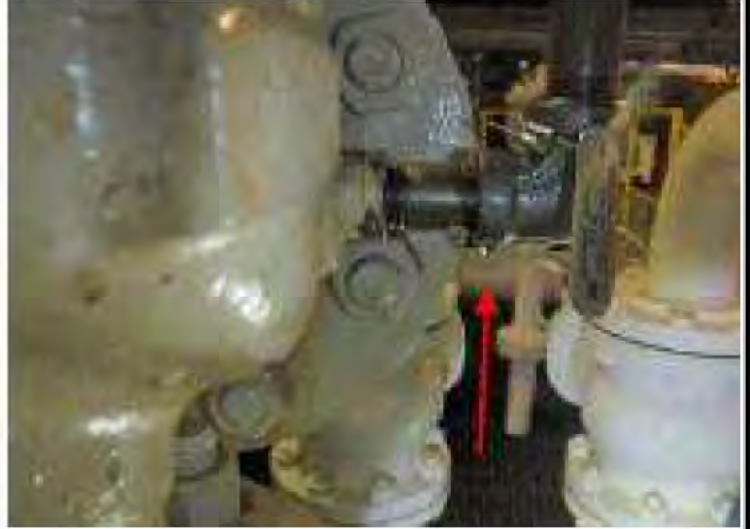
Representative photo of existing conditions: weeping on threaded connections on F-24 pressure relief system.

Replaced threaded plug of bottom of basket strainer, changed gaskets and bolts on spool for F-24 pressure relief system.

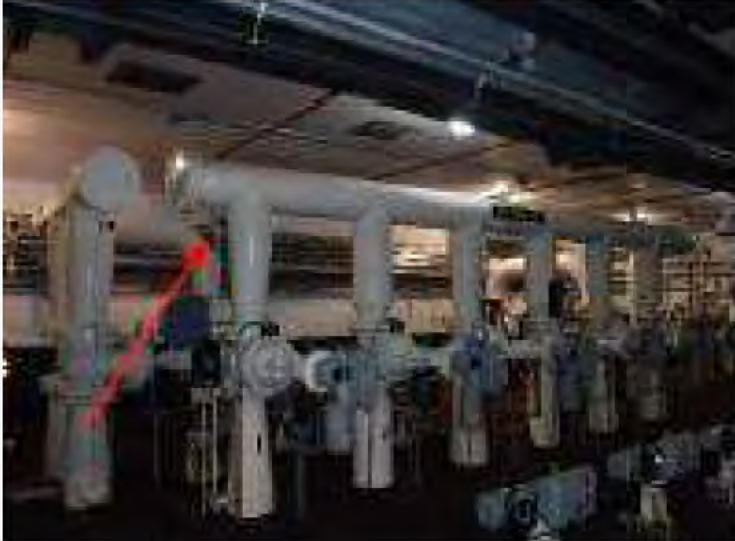
Repair Description Cont.: "Service or replace valve (b) (3) (A)

Existing condition: valve weeping by through grate into secondary containment trench.

Contractor replaced (b) (3) (A) valves on both sides of the JP-5 header with ball valves to eliminate weeping. During the course of normal operation, these valves are closed. During repacking, threaded connections will be monitored for weeping.

Replaced (b) (3) (A) valves on both sides of the JP-5 header.

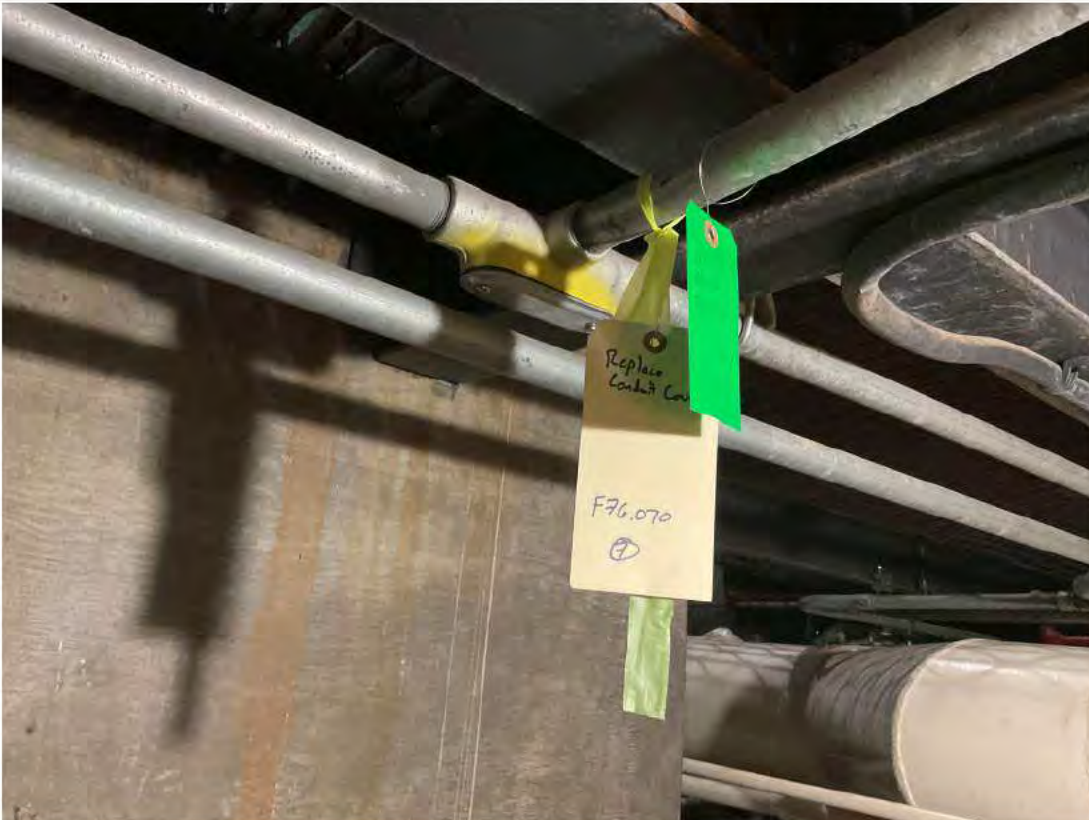
Source	PDF Page No.	Facility Geographic Area	Location Reference
NDAAs	61	Underground Pumphouse	Various
Repair Description	There are several open conduits, junction boxes, and unsealed electrical fittings throughout the UGPH that will not meet hazardous area ratings. Provide covers on electrical fittings.		Source Contract Reference 47QSHA18D000Y W912DY21F0025 Service Order 649
Description of Contractor QC Method(s) Used	Methods outlined in QASP. Visual examination of outlet cover installation, tagging each repair.		Contractor QC Records Reviewed QCP and Daily Reports.
Description of QA Validation and Observations	Methods outlined in QASP. JTF-RH secondary QA and 3rd Party QV completed. JTF-RH QV visually inspected repairs and reviewed contractor QC documentation (Work Plan, submittals, daily reports). Final acceptance by government. Date: 01 JUN 2023		
Rework Needed		Photo Record Attached	Repair Work Validated as Complete

Form 5 conduit cover installation (typical) with QA tags.

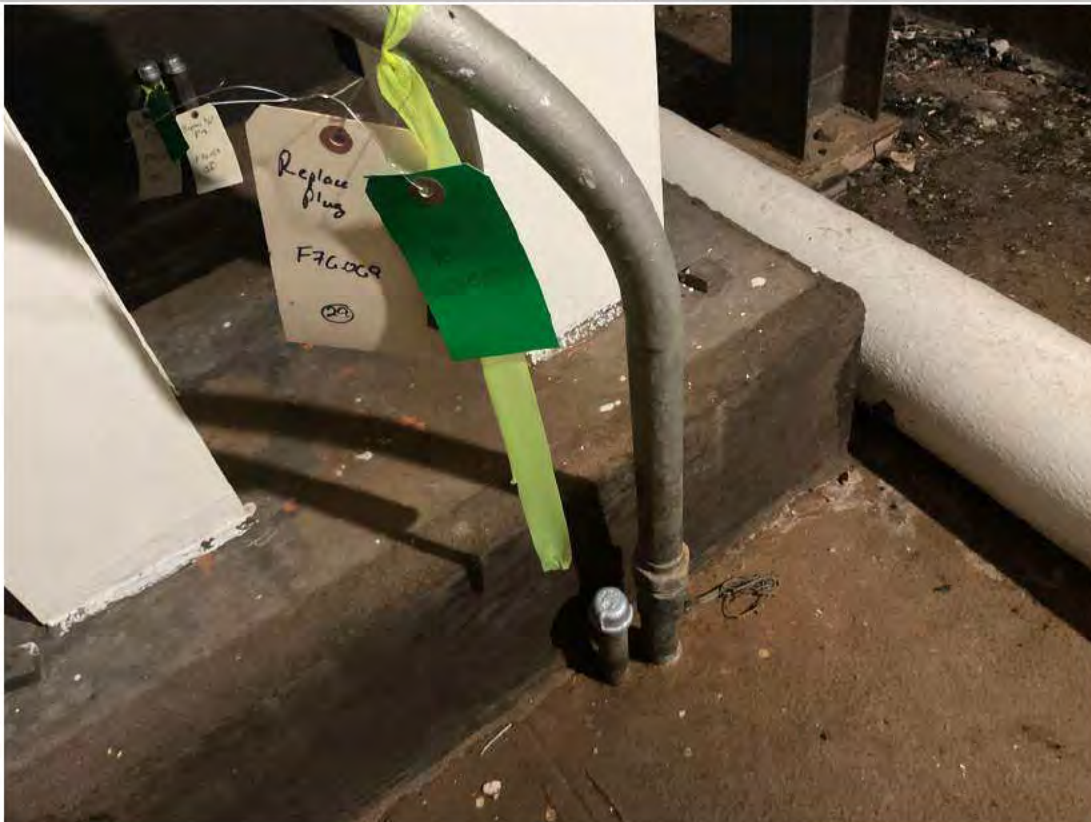
Source	PDF Page No.	Facility Geographic Area	Location Reference
NDAAs	62	Underground Pumphouse	Various
Repair Description	There are several locations throughout the UGPH where abandoned/open conduit penetrates the UGPH floor, potentially negating the secondary containment. Provide covers on open electrical conduits.		Source Contract Reference 47QSHA18D000Y W912DY21F0025 Service Order 649
Description of Contractor QC Method(s) Used	Methods outlined in QASP. Visual examination of threaded cap installation, tagging each repair.		Contractor QC Records Reviewed QCP and Daily Reports.
Description of QA Validation and Observations	Methods outlined in QASP. JTF-RH secondary QA and 3rd Party QV completed. JTF-RH QV visually inspected repairs and reviewed contractor QC documentation (Work Plan, submittals, daily reports). Final acceptance by government. Date: 01 JUN 2023		
Rework Needed		Photo Record Attached	Repair Work Validated as Complete

Cast iron round cap installation (typical) with QA tags.

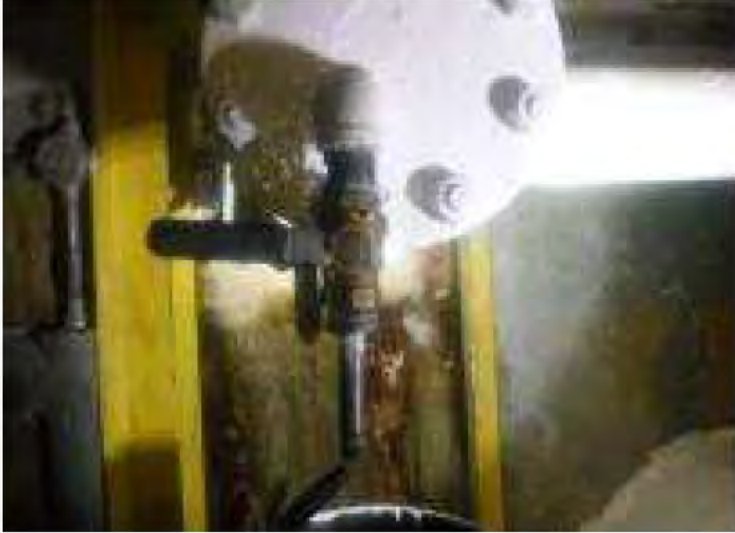
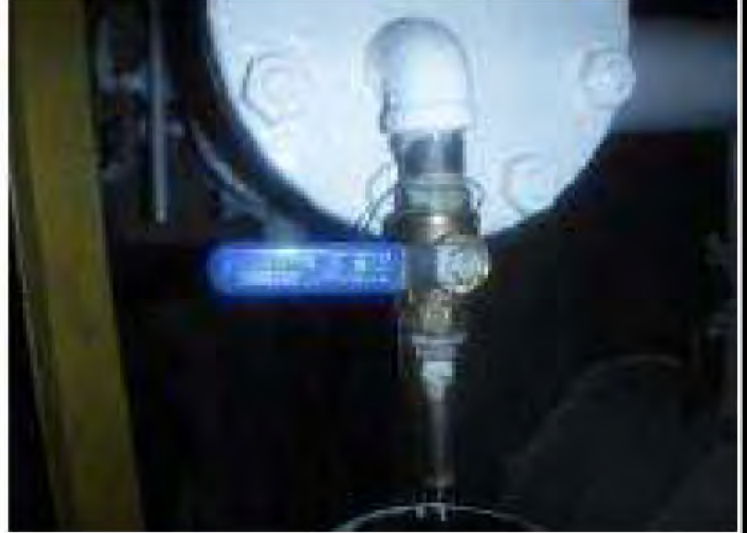
Existing condition: (b) (3) (A) ball valve on FOR line without plug at Surge Tank 3.

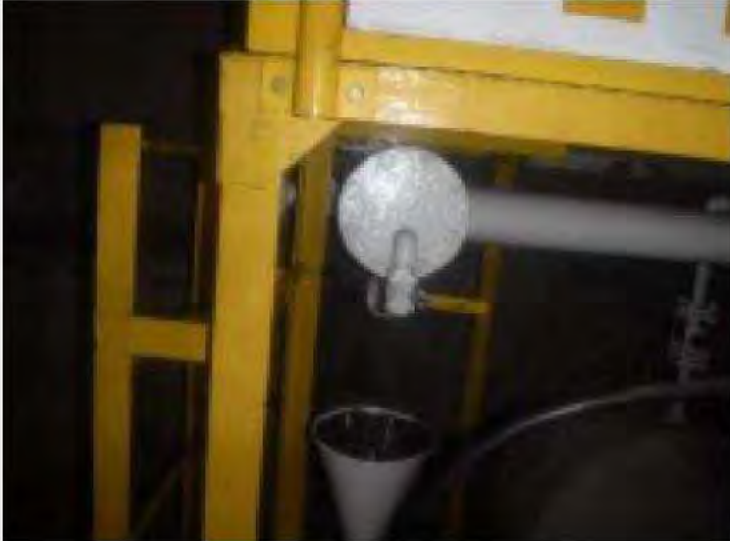
Existing condition (b) (3) (A) ball valve on FOR line without plug at Surge Tank 4.

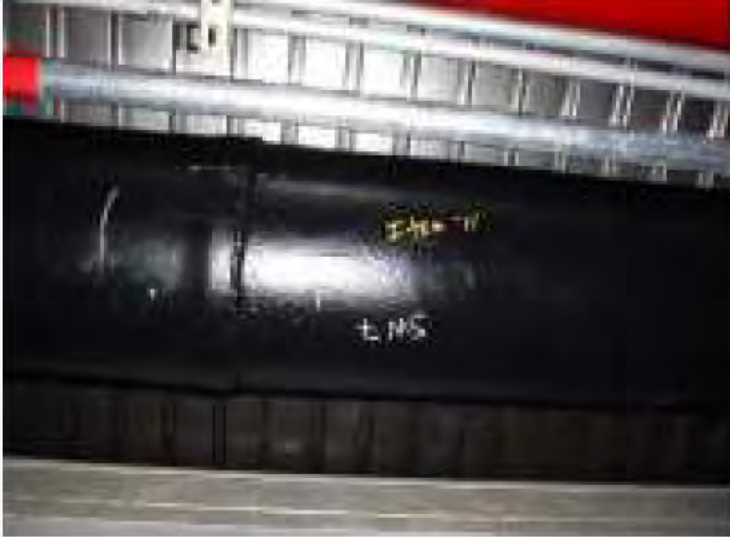
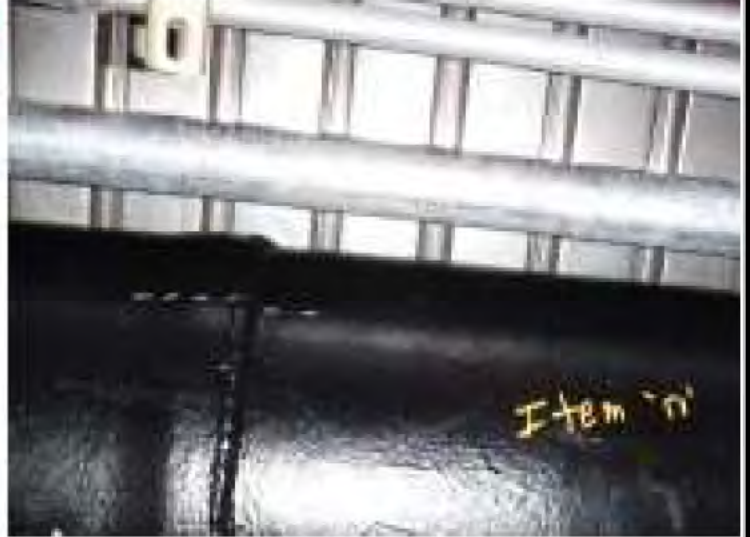
Existing condition of pipe at PS 59-60 of pipeline bell connection completed by fillet weld instead of butt welded connection.
